**Tree Inventory and Preservation Plan
111-115 Fiddlers Green Rd.
Hamilton, Ontario**

22 March 2022
rev. 4 May 2022

KUNTZ FORESTRY CONSULTING Inc. Project P3135

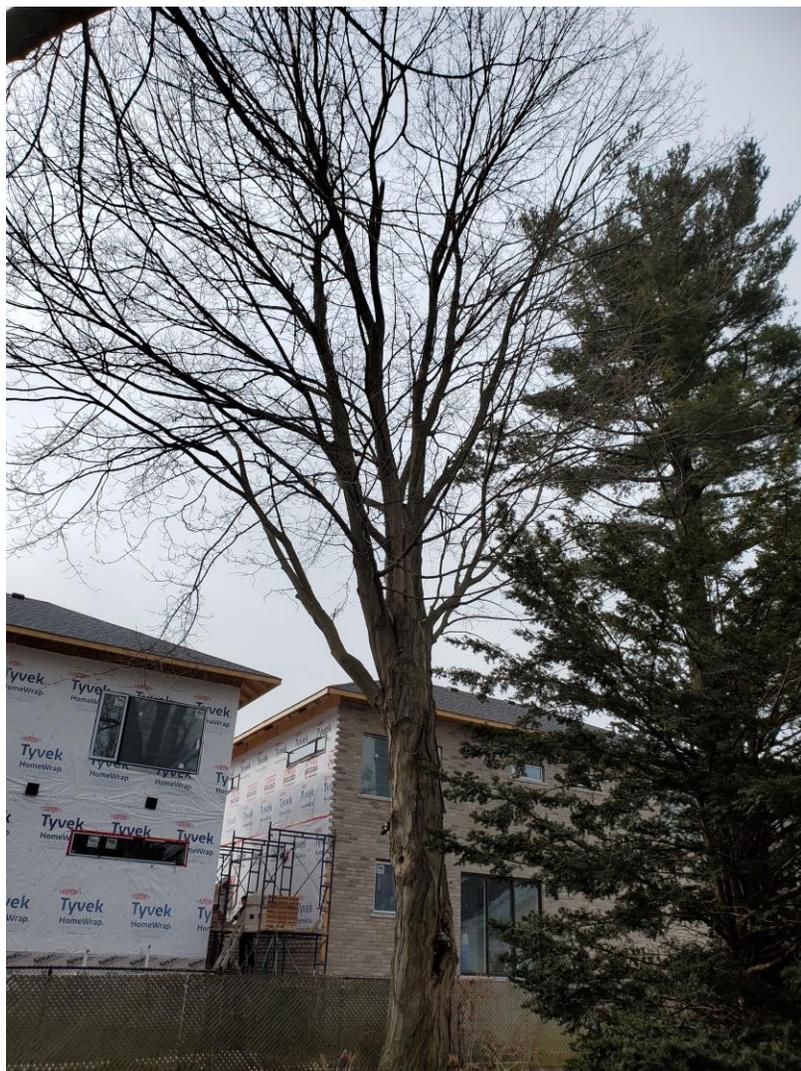
Tree 3

The removal of 9 trees will be required to accommodate the proposed development. Tree #3 should be removed based on condition (significant interior decay and fruiting bodies present on bole).

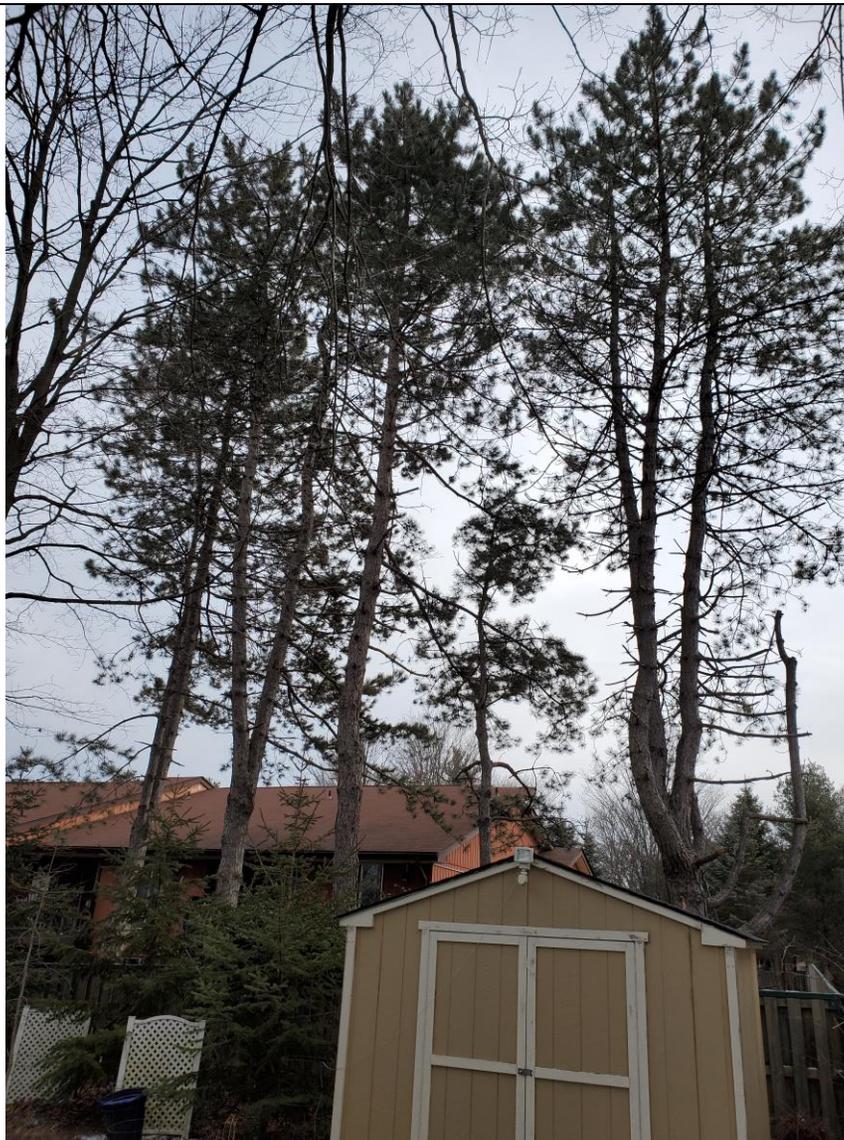
Trees N2 right to N6 left

N3	Austrian Pine	<i>Pinus nigra</i>	20	F	F	F	20	F	3	suppressed, poor structure, lean	Neighbour	Retain
N4	Austrian Pine	<i>Pinus nigra</i>	36	F	F	F	20	F	4	poor structure. Lean, multi-stem at 3m	Neighbour	Retain
N5	Austrian Pine	<i>Pinus nigra</i>	32	F	F	F	20	F	4	poor structure. Lean, multi-stem at 4m	Neighbour	Retain
N6	Austrian Pine	<i>Pinus nigra</i>	34	F	F	F	20	F	4	poor structure. Lean, multi-stem at 5m	Neighbour	Retain

- Special Mitigation Measures are prescribed for Trees #1, N3, N4, N5 and N6. See above and Figure 1.
- Branches that extend beyond prescribed tree protection zones that require pruning must be pruned by a qualified Arborist or other tree professional. All pruning of tree branches must be in accordance with Good Arboricultural Standards.
