RIVERWALK SUBDIVISION

7253 RAINHAM ROAD, HAMLET OF BYNG

SCOPED ENVIRONMENTAL IMPACT STUDY

SEPTEMBER 2020

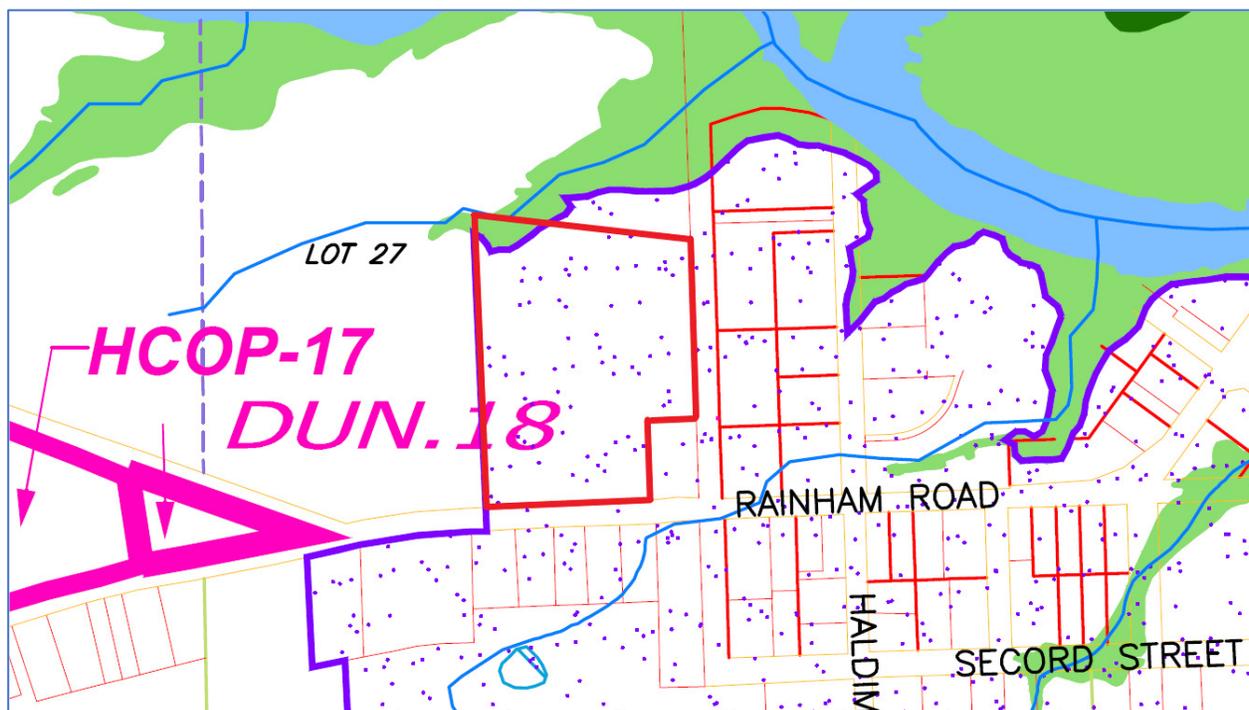
Figure 1: Haldimand OP Schedule C.3 excerpt with the site highlighted (thick red line), within the Hamlet of Byng (thick purple line), except for Riverine Hazard Lands (green fill) in the site's northwest corner.

OP Schedule C.3 (Figure 1, below) shows the site within the boundary of the Hamlet of Byng except for a small area where Riverine Hazard Lands associated with a small tributary watercourse extend from the Grand River across Byng Island Conservation Area lands and into the northwest corner of the site. Haldimand OP Schedule E.3 shows the Hamlet of Byng adjacent to the Grand River Marshes (designated in the OP as Natural Environment / Wetland Area #26) which includes the Grand River Marshes Provincially Significant Wetland Complex, Life Science Area of Natural and Scientific Interest and Environmentally Significant Area.

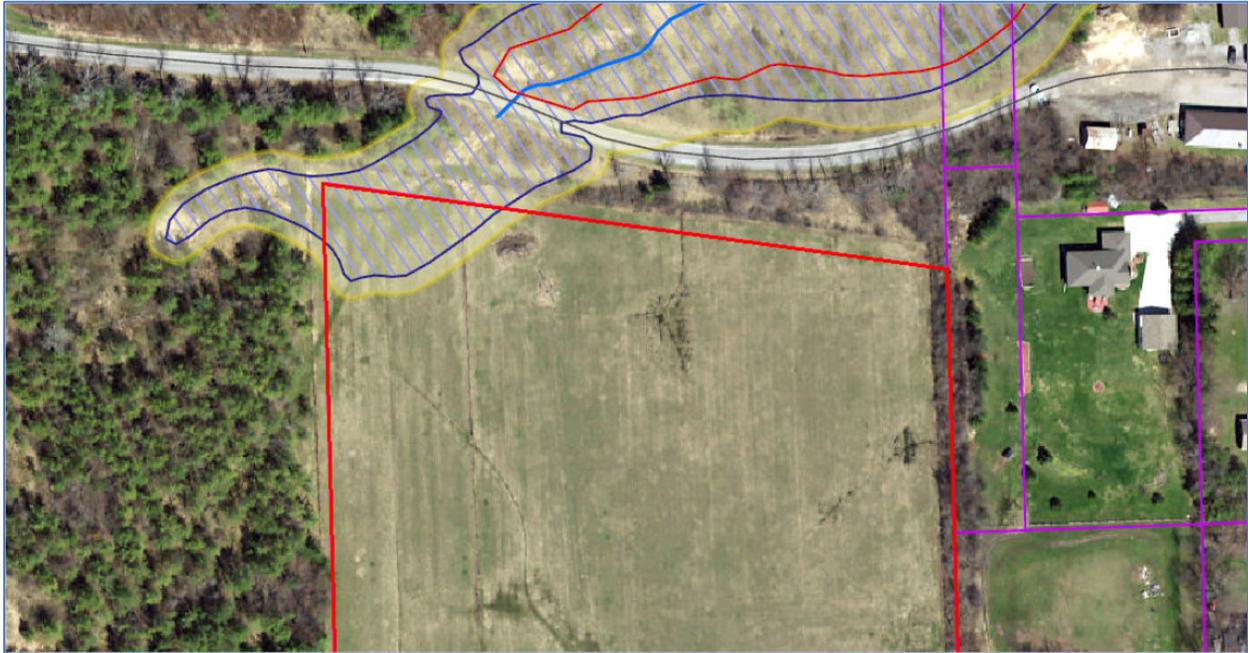
Figure 2: Excerpt of GRCA Regulation Mapping that was provided by GRCA at Pre-Consultation 07 November 2018, showing floodplain (blue outline and diagonal hatching) and regulation limit (yellow line and shading) extending into the northwest corner of the site (red property boundary).

GRCA regulation mapping was provided by GRCA at Pre-Consultation (Figure 2, below) that identified regulatory floodplain and regulation limit within the site's northwest corner. GRCA regulation mapping was subsequently revised (Figure 3, below) to extend the regulated watercourse into the hayfield in the site's northwest corner. The extent of a defined watercourse onto the site, versus ephemeral drainage swale, will be discussed later in this Scoped EIS.

Note that the GRCA regulation mapping also shows a distinct separation of the site from vegetated features

of the Conservation Area woodland to the west and from the hedgerow to the north.

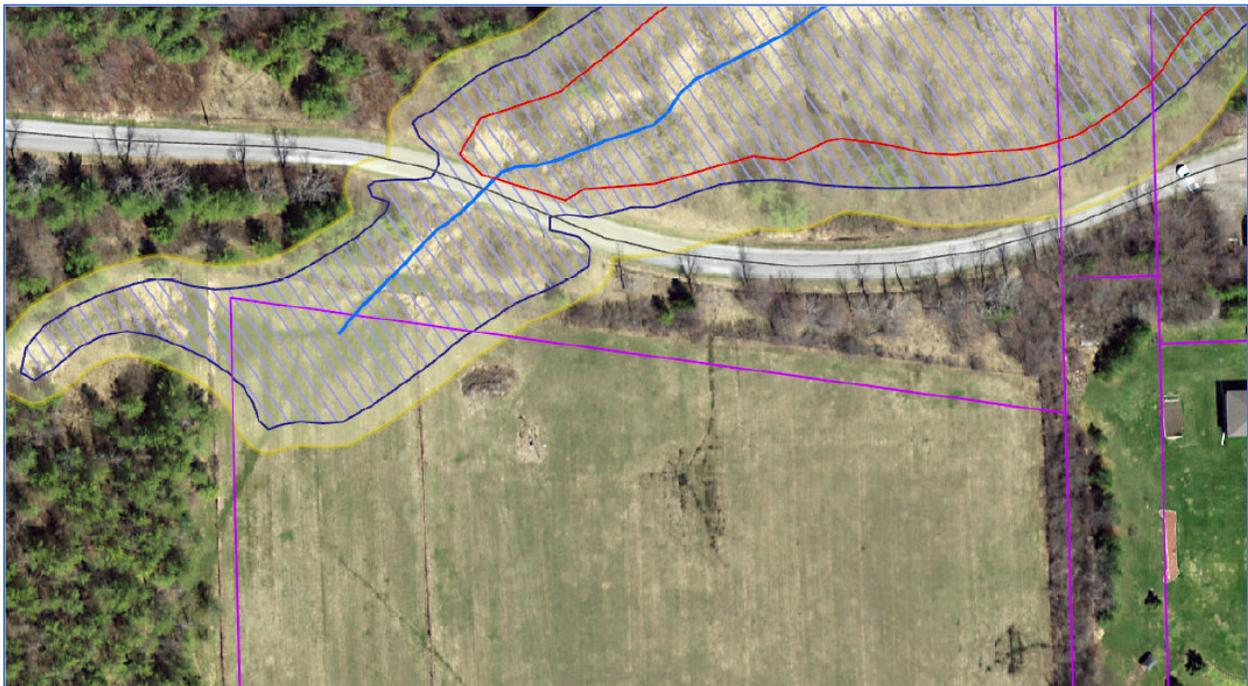
Figure 3: Excerpt of the GRCA Regulation Mapping downloaded 23 April 2019, showing extension of the regulated watercourse to a point in the hayfield approximately 5 metres into the site.

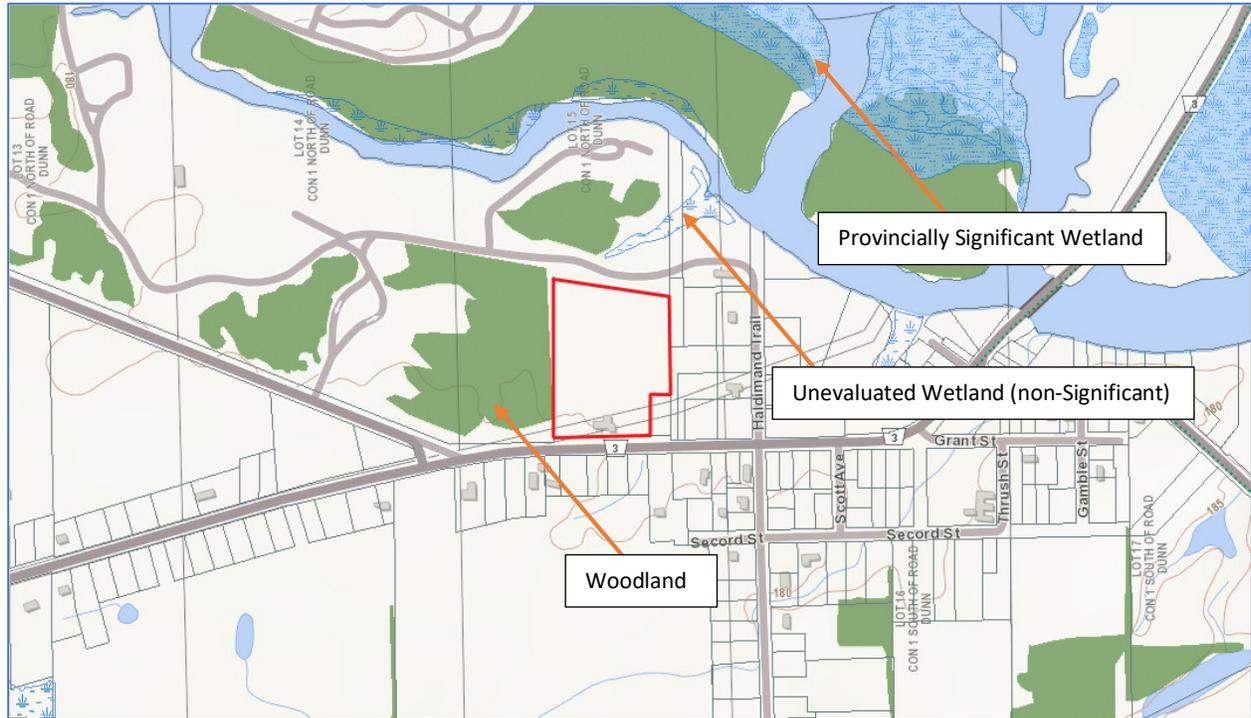
Figure 4: NHIC online mapping excerpt showing the site (red outline) in relation to distant Provincially Significant Wetland (light blue “vegetation” fill) in the main axis of the Grand River, Unevaluated Wetland (i.e., non-Provincially Significant Wetland) (“vegetation” fill without blue shading) along the tributary north of the site, and adjacent woodland (dark green fill) on Conservation Area lands west of the site.

NHIC online mapping (Figure 4, below) shows the site far (~370 metres) from the nearest Provincially Significant Wetland which is within the Grand River. The wetland closest to the site is the Unevaluated (i.e., non-Provincially Significant) Wetland associated with the lowermost portion of the tributary swale and watercourse north of the site. The Unevaluated Wetland is >40 metres from the site. The tributary watercourse is not shown on NHIC mapping. NHIC mapping does show the extent of woodland on the Byng Island Conservation Area lands, including the woodland block west of the site.

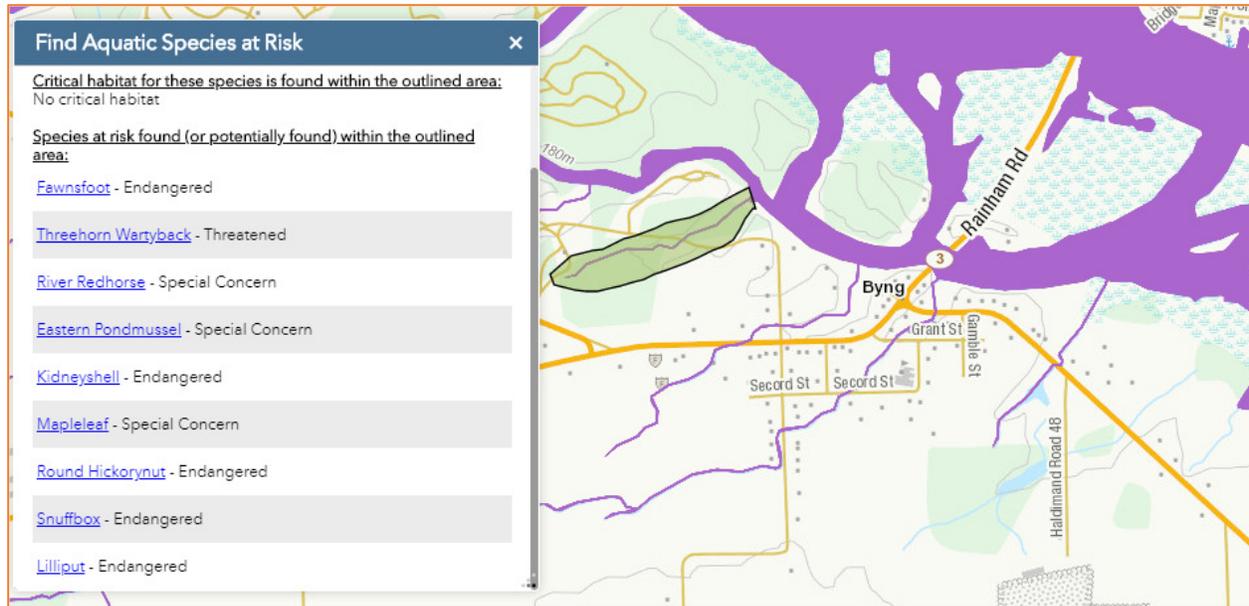
Figure 5: Excerpt of DFO’s online Aquatic SAR mapping showing the 9 aquatic SAR, including 1 fish and 8 mussel species, listed for the tributary watercourse north of the site (and all other nearby Grand River tributaries and adjacent portions of the Grand River).

DFO’s online aquatic SAR mapping (Figure 5, below) indicates the potential occurrence of nine aquatic SAR, including 8 freshwater mussel SAR and one fish SAR, in the tributary north of the site. The mapping indicates that no critical habitat of aquatic SAR occurs within the tributary. It’s worth noting that the DFO mapping produces the same SAR list for each of the nearby Grand River tributaries and within adjacent portions of the Grand River. As such, the aquatic SAR list generated for the tributary north of the site reflects *potential* aquatic SAR occurrence based on the connection with SAR occurrence in the Grand River and does not denote confirmed occurrence of those SAR or habitat suitable for their existence, within the tributary watercourse and swale. In other words, the DFO mapping is a trigger for SAR screening within the swale and watercourse, and not confirmation of the presence of each of the listed species.

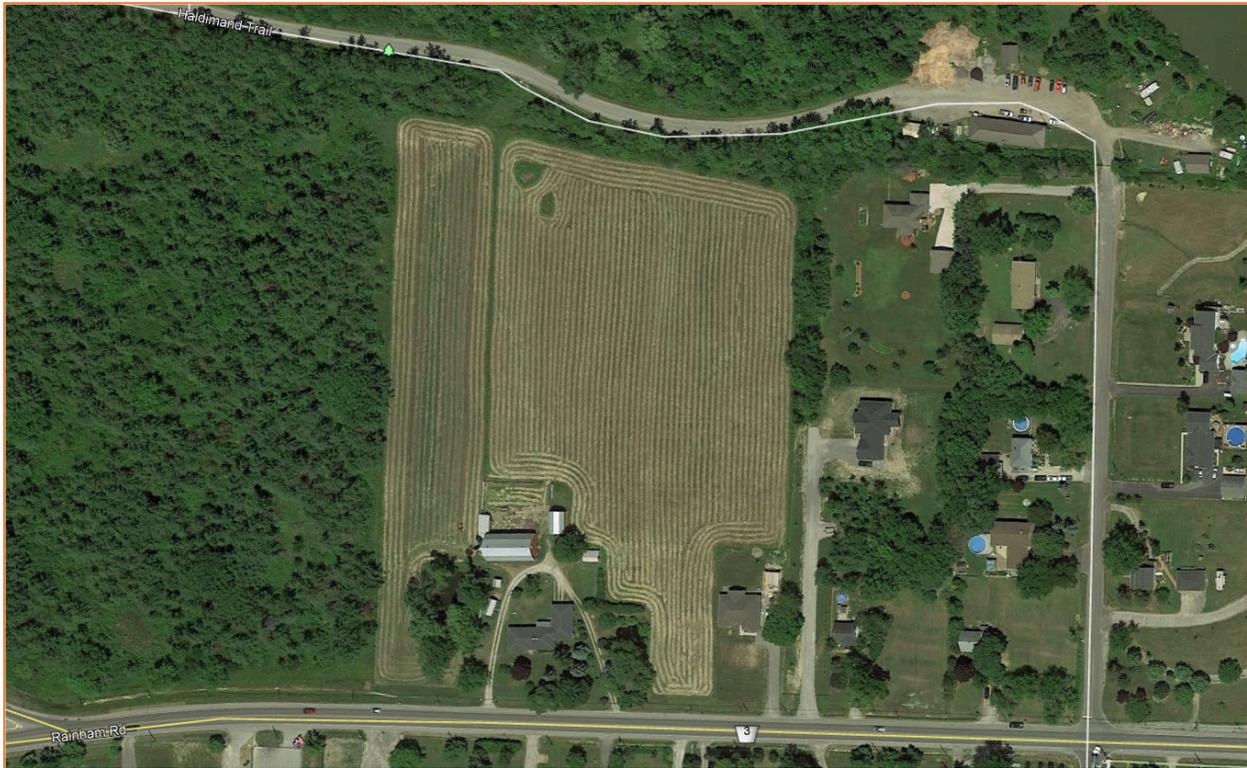
Figure 6: Air photo of the site (excerpt of Google Earth 2018 image) showing the existing home, outbuildings, manicured area and agricultural fields. GRCA woodland is visible to the west. The GRCA-regulated swale/floodplain in the northwest corner is invisible, but windrows of cut hay are evident.

Myler observed the site as containing an existing home, barn and associated outbuildings, manicured area and farm fields (see Figure 6, below, and attached representative photos). There are no natural vegetation features on the site. Manicured area surrounds the existing home and outbuildings in the southern portion of the site. The manicured area includes planted shade trees and a small artificial dugout pond that is isolated from and not connected to any watercourse. The rest of the site is an active agricultural field, a hayfield/pasture, that was observed to be in a deeply ploughed condition on Myler’s visits because of the archaeological investigation.

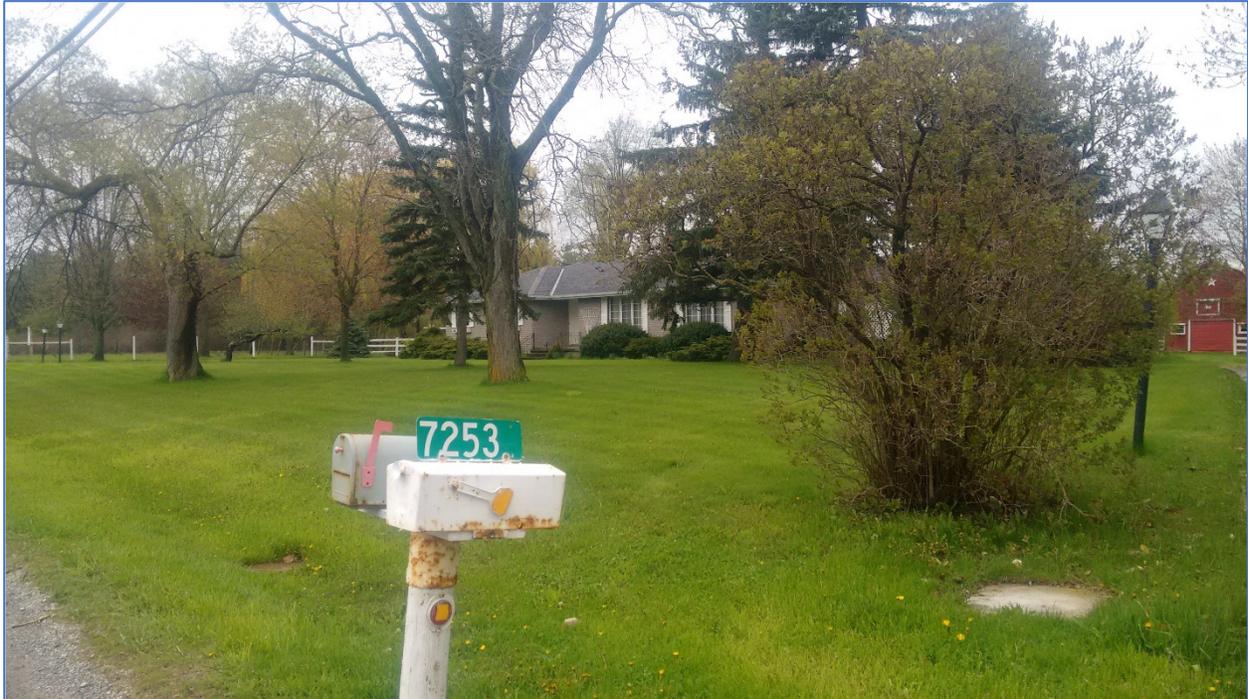
Photo 1: Existing home and manicured area fronting on Rainham Road.

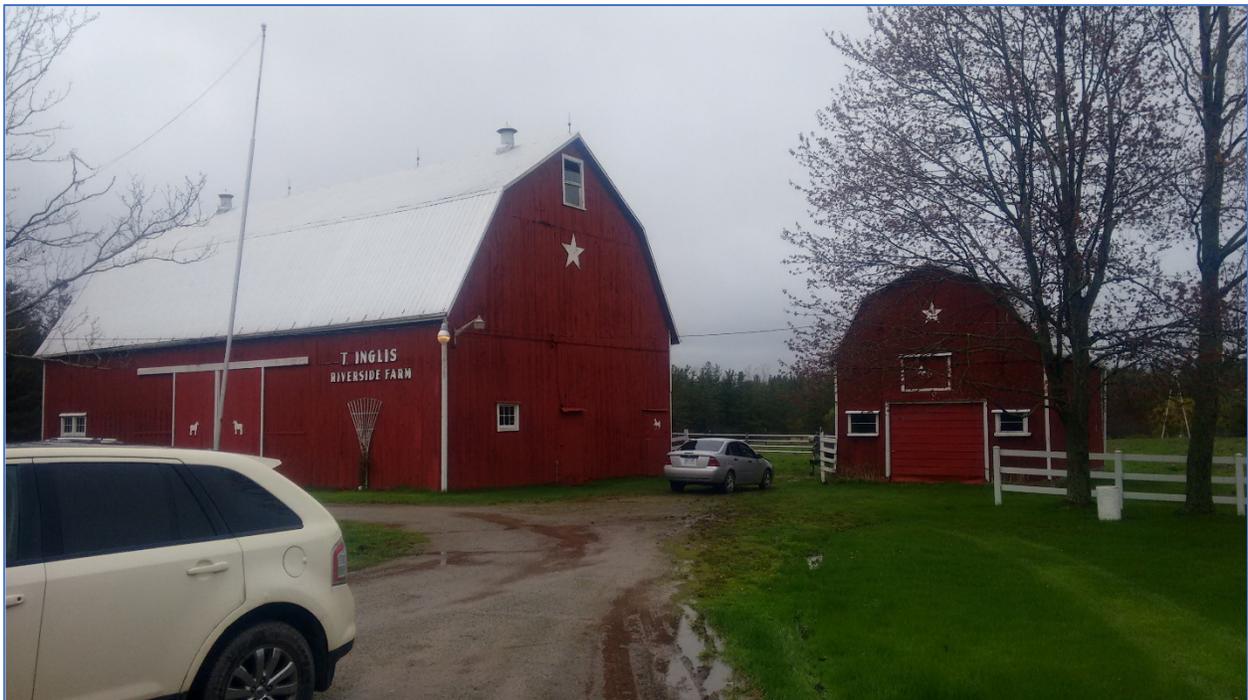
Photo 2: Barn, detached garage and surrounding manicured area.

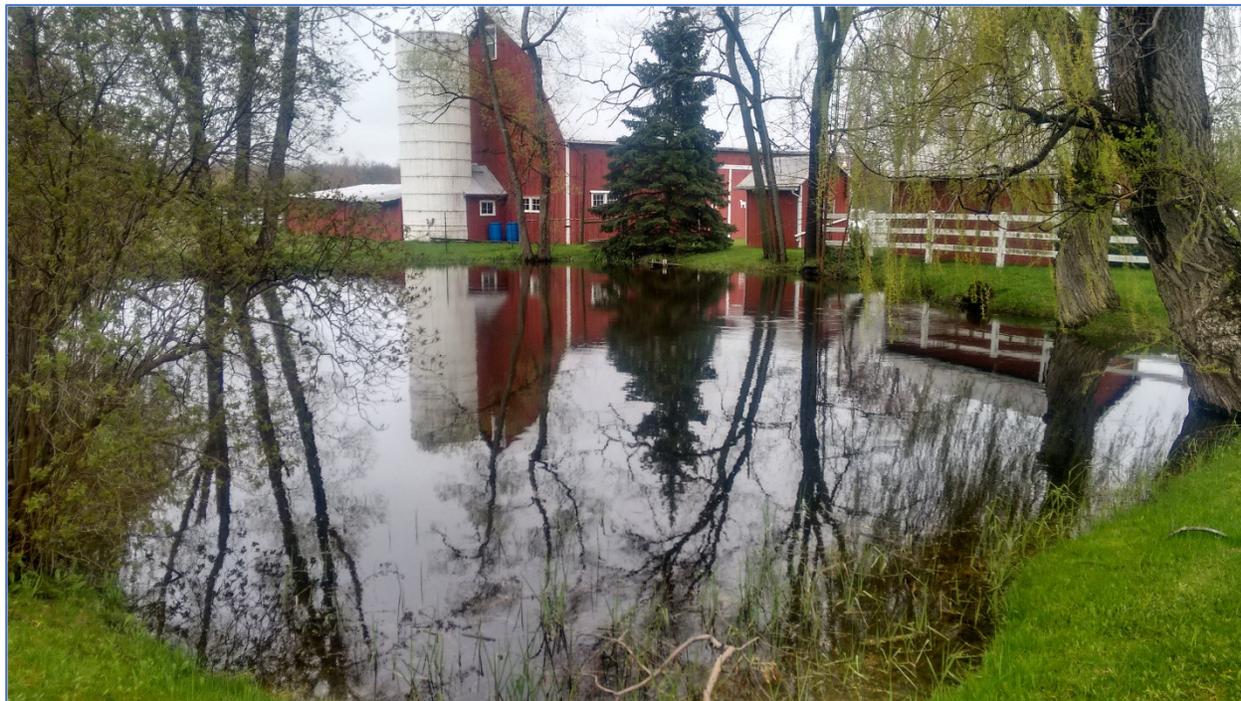
Photo 3: Artificial dugout pond and surrounding shade trees within the site's manicured area.

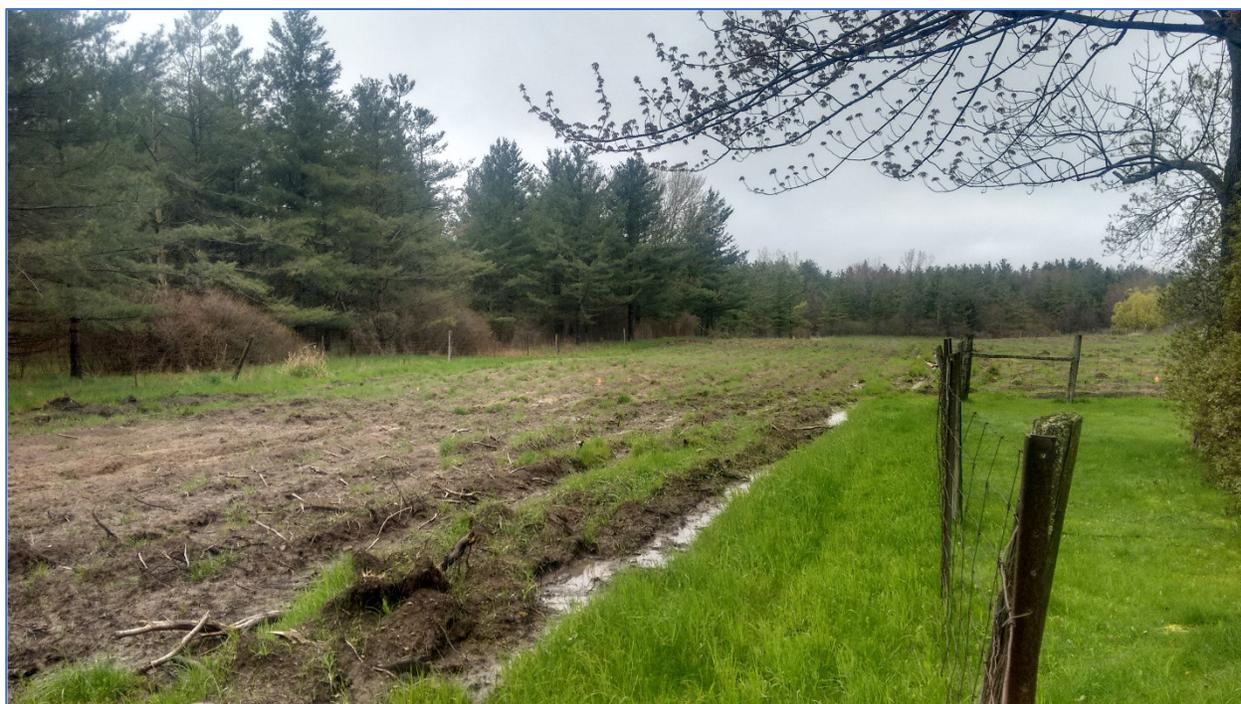
Photo 4: Western limit of the site, looking across hayfield/pasture northward along the edge of the Conservation Area woodland. Planted coniferous woodland trees are set back from the site behind the boundary paige-wire fence.

The woodland in the Byng Island Conservation Area was observed to be conifers that were planted set back from the boundary fence by approximately 3-5 metres in most places. Some tree branches overhang the site boundary, but only by a few metres.

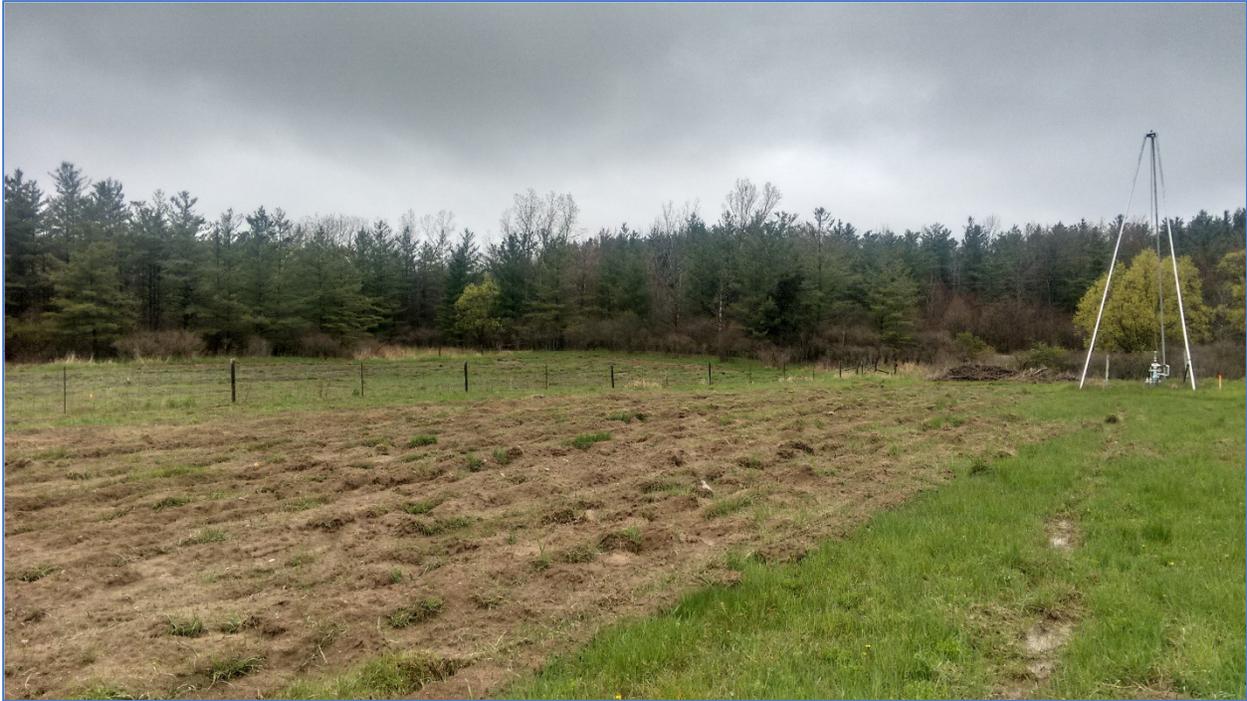
Photo 5: Facing into the site’s northwest corner. The ephemeral drainage swale and GRCA-regulated floodplain occupies the low area just beyond the fence (centre-rear).

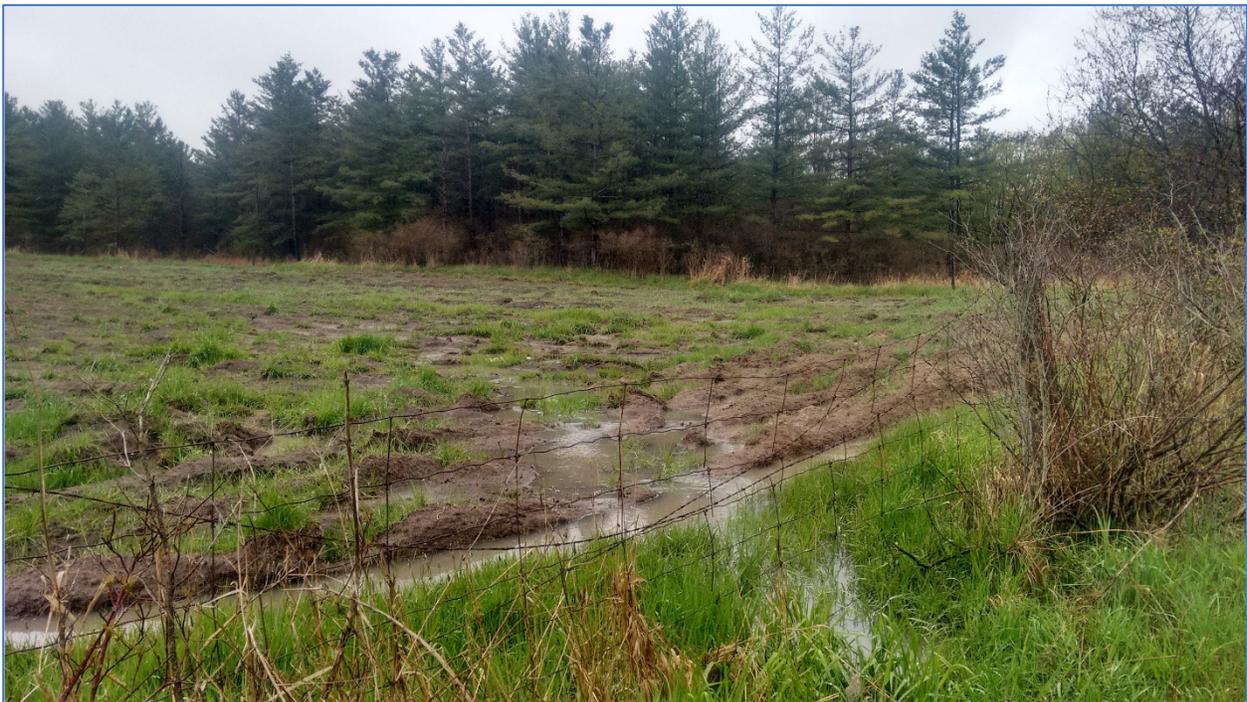
Photo 6: Facing southwest over the fence from the Conservation Area at the ephemeral swale in the site’s northwest corner. Very wet spring conditions caused standing water in furrows and flow within the swale, but no defined channel was evident on either side of the site boundary.

Myler's observations at the site and north across the fence onto the Byng Island Conservation Area confirmed that an ephemeral swale occurs in the northwest corner of the site. The swale is entirely vegetated

by upland hayfield/pasture and does not contain a defined stream channel, pools or other features of aquatic habitat. The swale therefore does not possess fish habitat or habitat of freshwater mussel and fish SAR. Review of aerial imagery taken prior to the archaeological ploughing shows hayfield and hay harvest extending uninterrupted across the swale area into the northwest corner of the site. The swale is barely distinguishable in the aerial photographs.

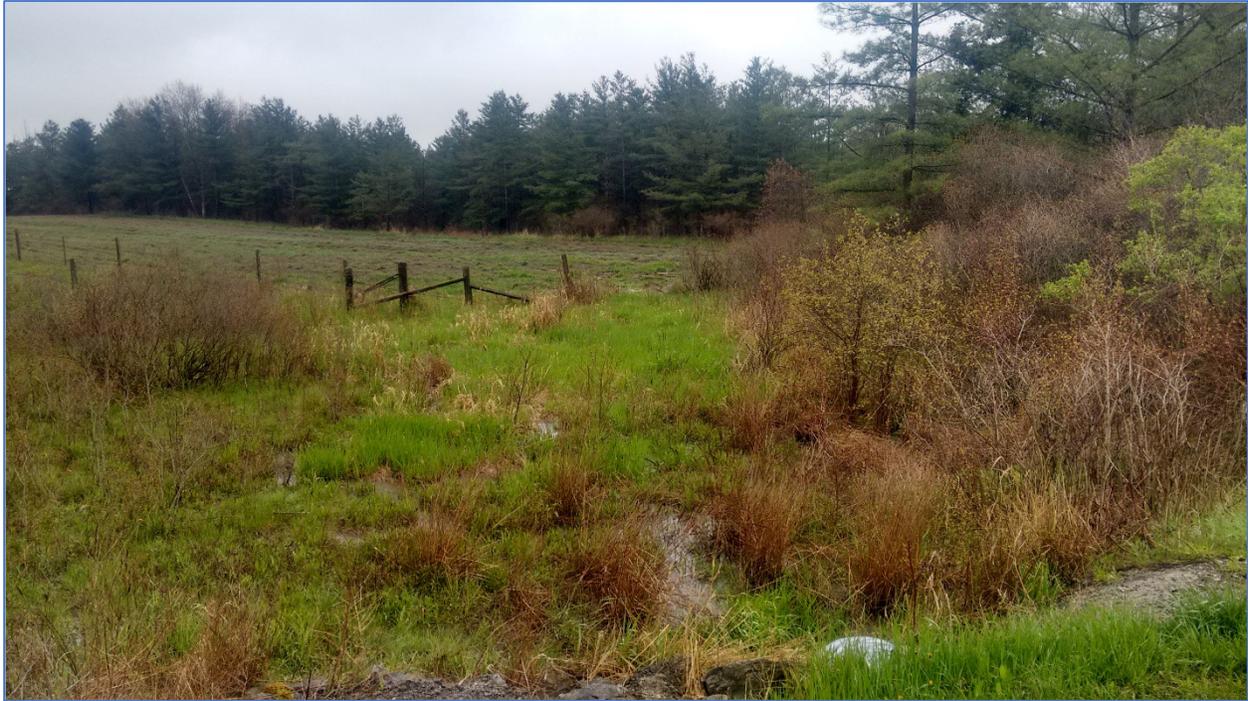
Photo 7: Facing southwest up the swale from the Haldimand Trail crossing within the Conservation Area. Flow was diffuse within the vegetated swale, with no defined watercourse channel.

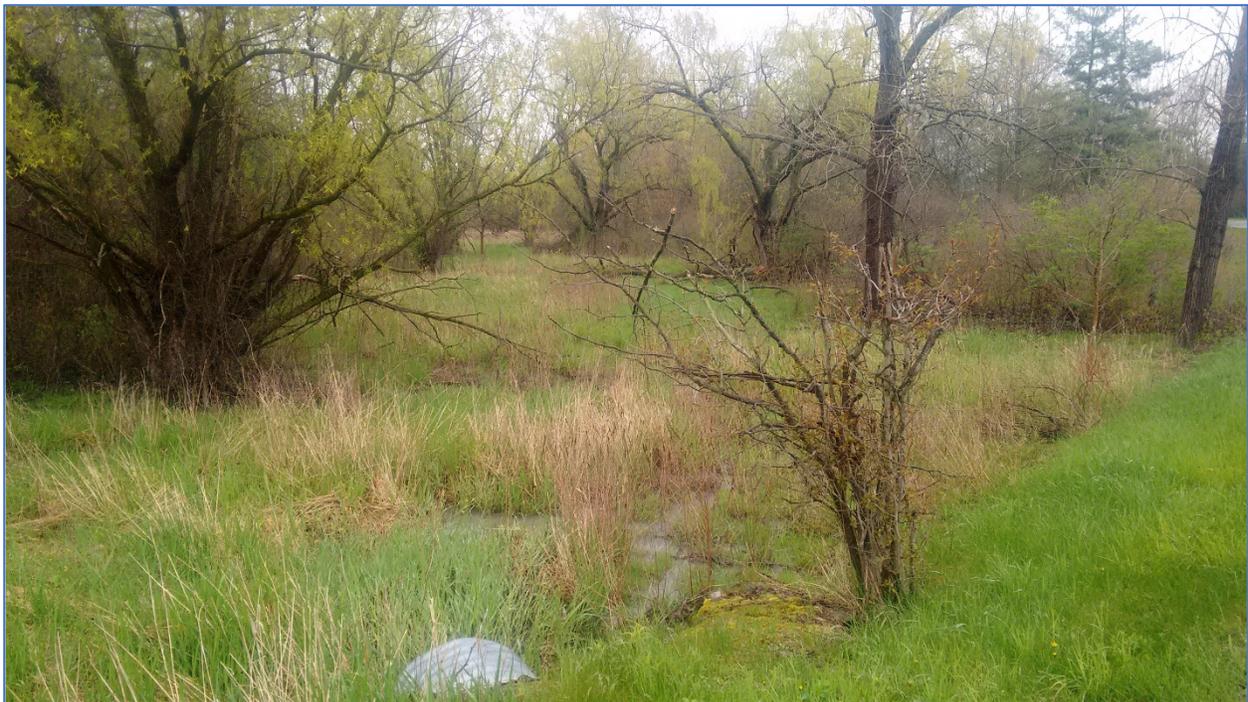
Photo 8: Facing northeast down the swale from the Haldimand Trail crossing in the Conservation Area. A broad vegetated floodplain area occurs downstream of the culvert with no distinct channel and no habitat suitable for the listed aquatic SAR fish and freshwater mussels.

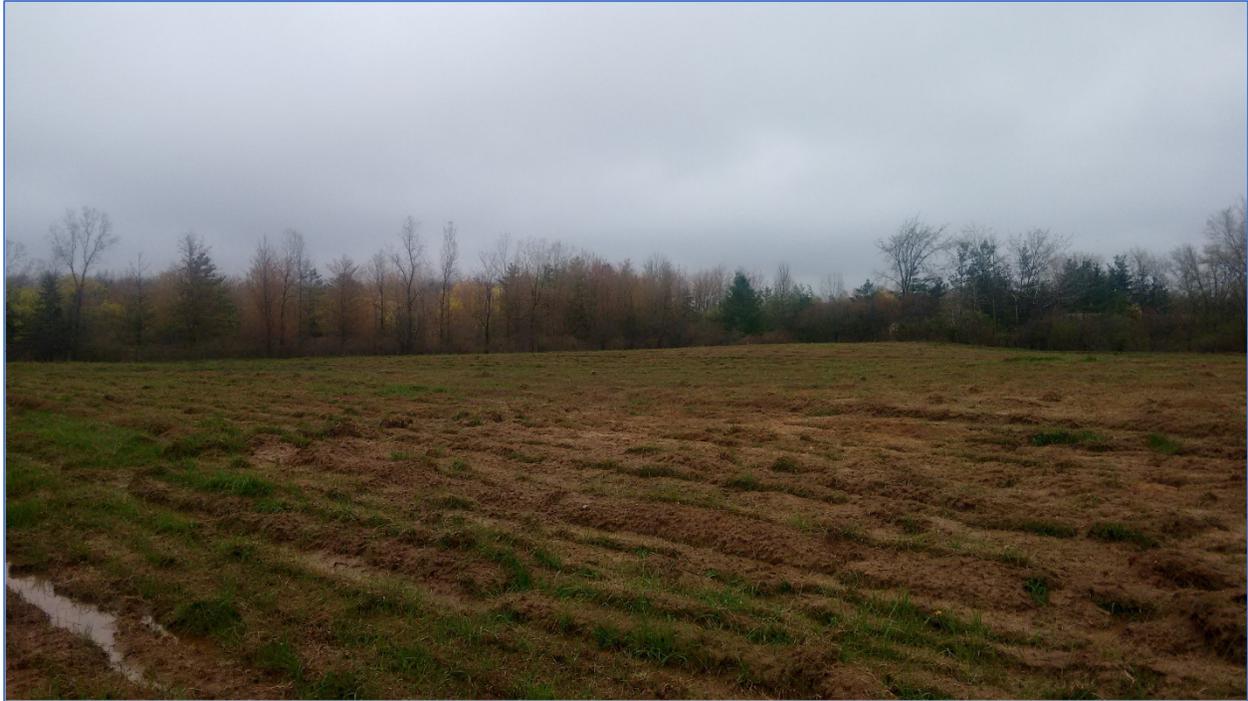
Photo 9: Facing north across the site's hayfield/pasture area, with hedgerow and trees of Byng Island Conservation Area visible in the background.

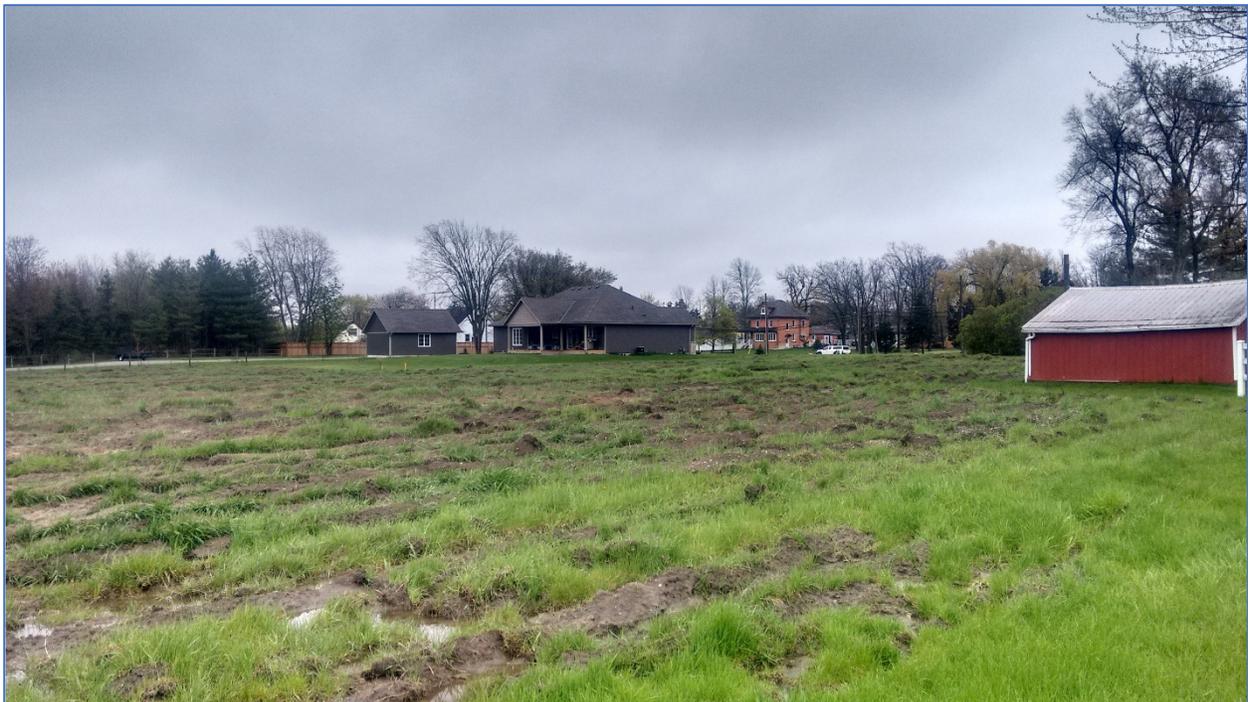
Photo 10: Facing southeast across the site's hayfield/pasture towards the recently constructed neighbouring home within the lot and to other Rainham Road homes in the background.
