**CONSERVATION AUTHORITY REGULATED AREAS ASSESSMENT
251 STONE CHURCH ROAD WEST**

Prepared for:
2806131 ONTARIO LIMITED

Prepared by:
Colville Consulting Inc.

C22033
May 2022

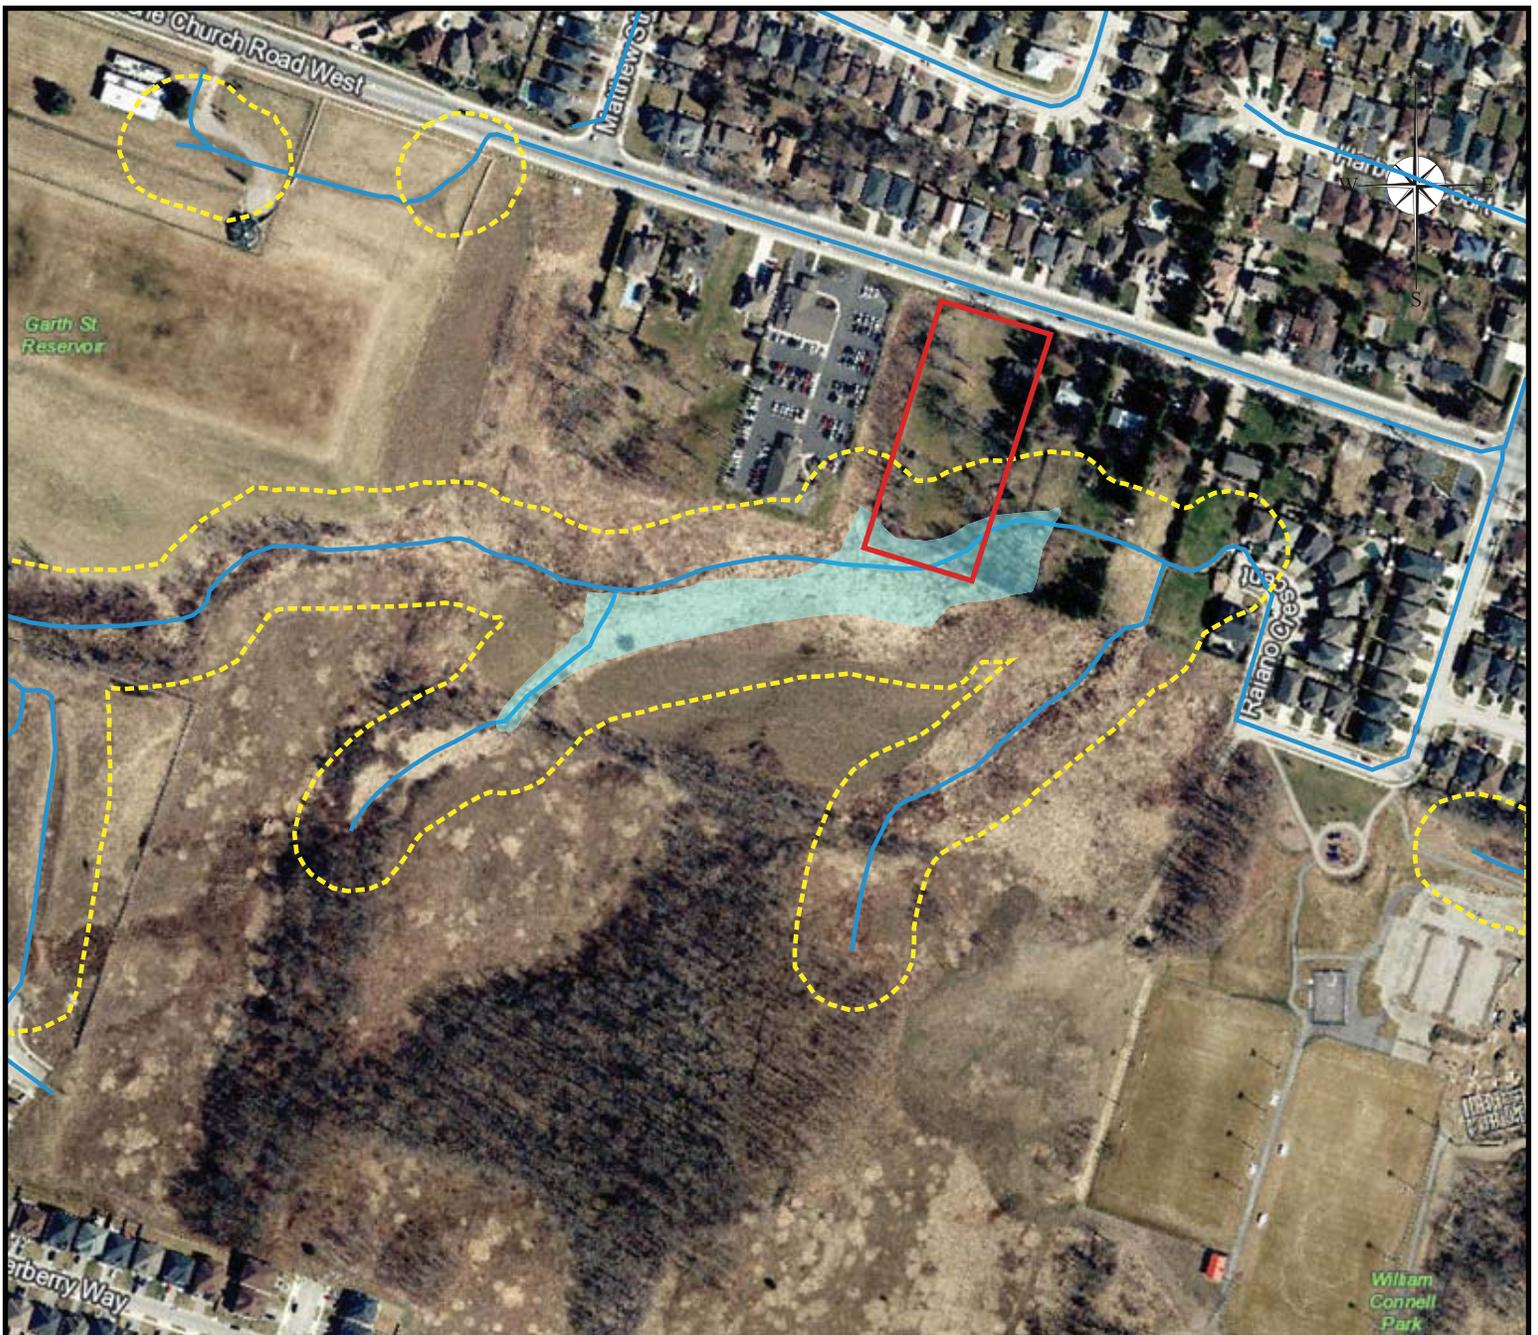
Figure 1
Mapped HCA Regulated Areas
on the Subject Property

Based on our review of Hamilton Conservation Authority mapping, it is our understanding that mapped Conservation Authority regulated features on the property include a wetland and watercourse, along with adjacent lands associated with these features (see Figure 1).

As illustrated in Figure 1, a watercourse is located in the southeast corner of the property. From a review of background mapping, this watercourse originates approximately 700m southwest of the property and is considered to be part of the Upper Ottawa sub-watershed. This feature drains an area of approximately 26ha and conveys this water to a storm sewer located approximately 130m downstream of the property. This water is ultimately conveyed to the Red Hill Creek via this storm sewer, however the actual outlet location is not known.

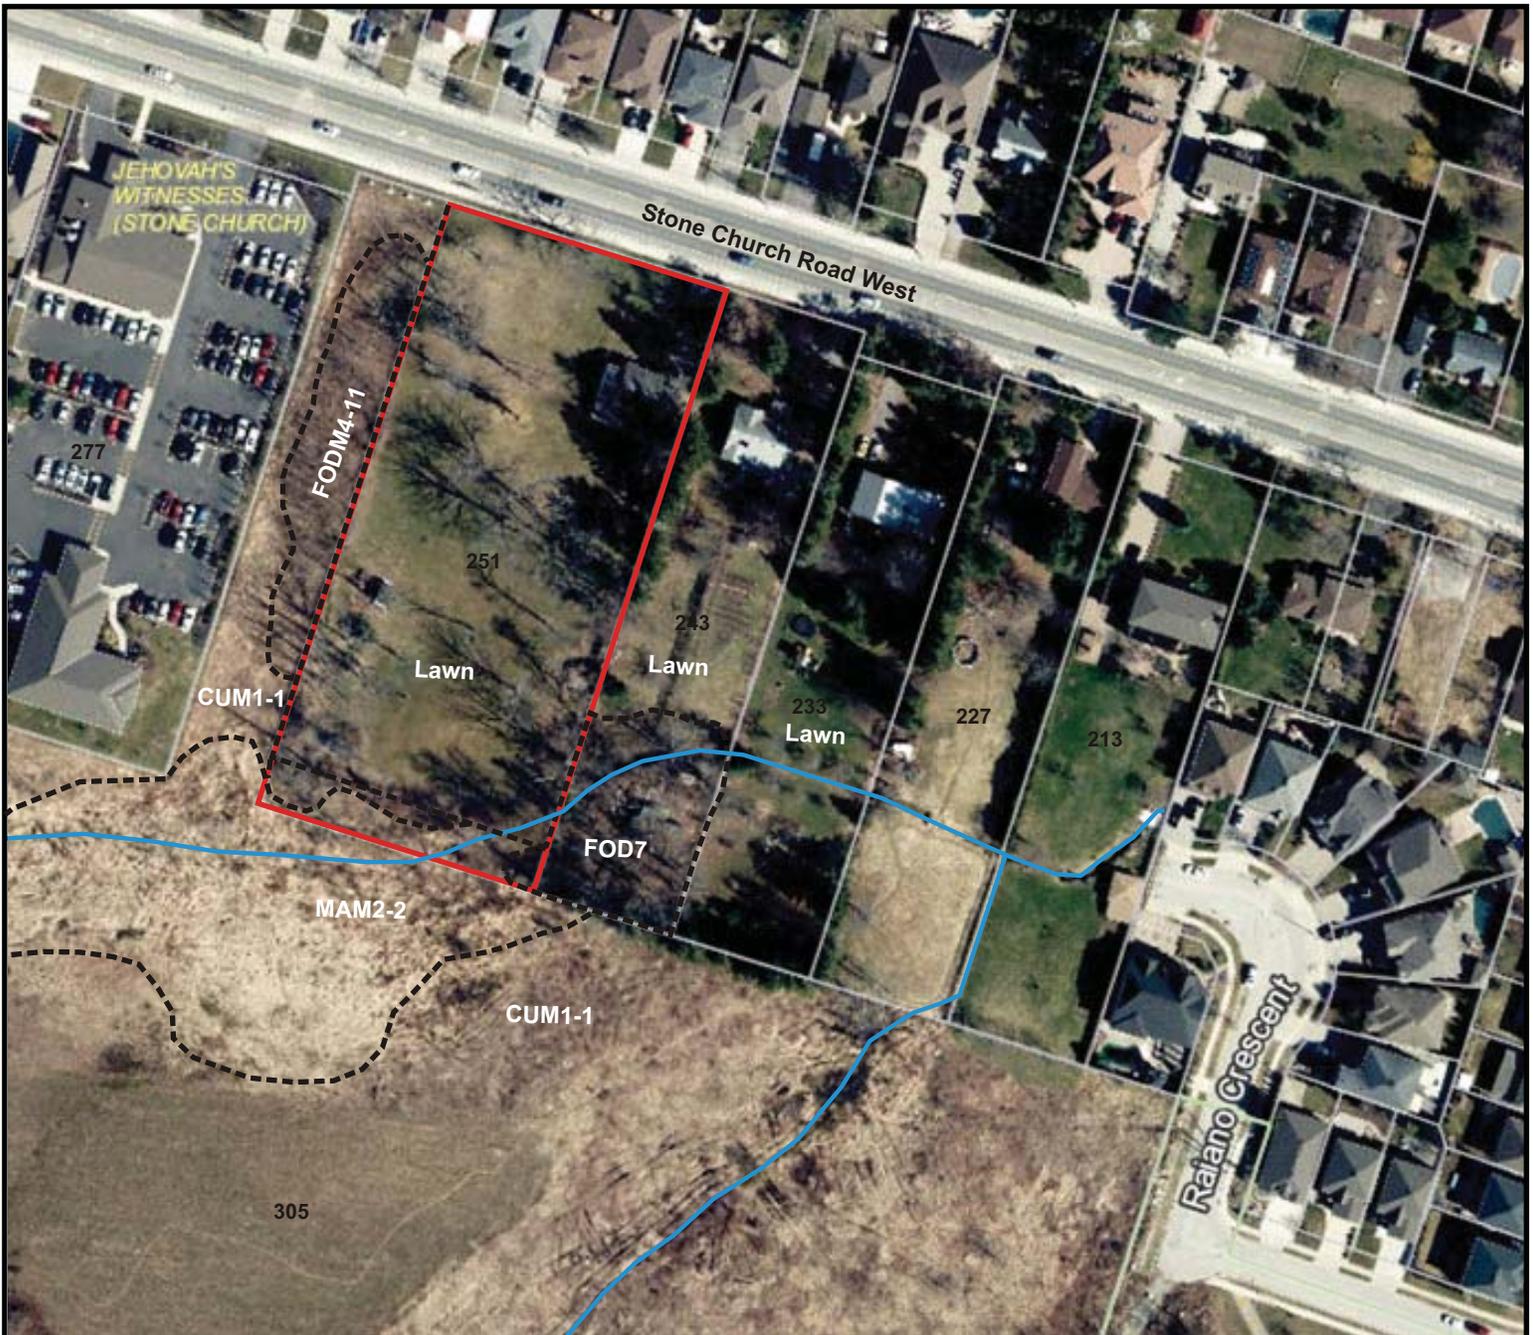
Figure 2
Extent of Vegetation Communities
on the Subject Property

Vegetation over much of the Subject Property consists of manicured lawn, with scattered trees primarily located on the southern portion of the property. Vegetation within the lawn area consisted primarily of Kentucky Blue Grass, with a mix of additional herbaceous species such as Common Dandelion, Sedge species and turf grass species. Lands to the south of the property were not surveyed extensively as part of this project, however vegetation over much of those lands appears to consist of meadow and meadow marsh. Further description of vegetation communities on and adjacent to the property are provided below.

Located in the southern portion of the property, as well as lands west of the property, are areas described as Dry-Moist Old Field Meadow Type (CUM1-1). This vegetation community was dominated by Tall Goldenrod and Canada Goldenrod, with New England Aster, Kentucky Blue Grass, Curly Dock, Garlic Mustard and White Sweet-clover also occurring.

Located on and adjacent to the southern portion of the property is an open meadow marsh community, which was described as a Reed-canary Grass Mineral Meadow Marsh Type (MAM2-2), with complexes of Forb Mineral Meadow Marsh Type (MAM2-10). This vegetation community generally occurs in association with a watercourse, and based on air photo interpretation, extends throughout much of the watercourse south of the property. Reed Canary Grass, Purple Loosestrife and Tall Goldenrod are abundant, with *Agrostis* species and Grass-leaved Goldenrod forming close to 100% vegetation cover in the ground layer. Reed Canary Grass is the dominant species throughout much of this community,

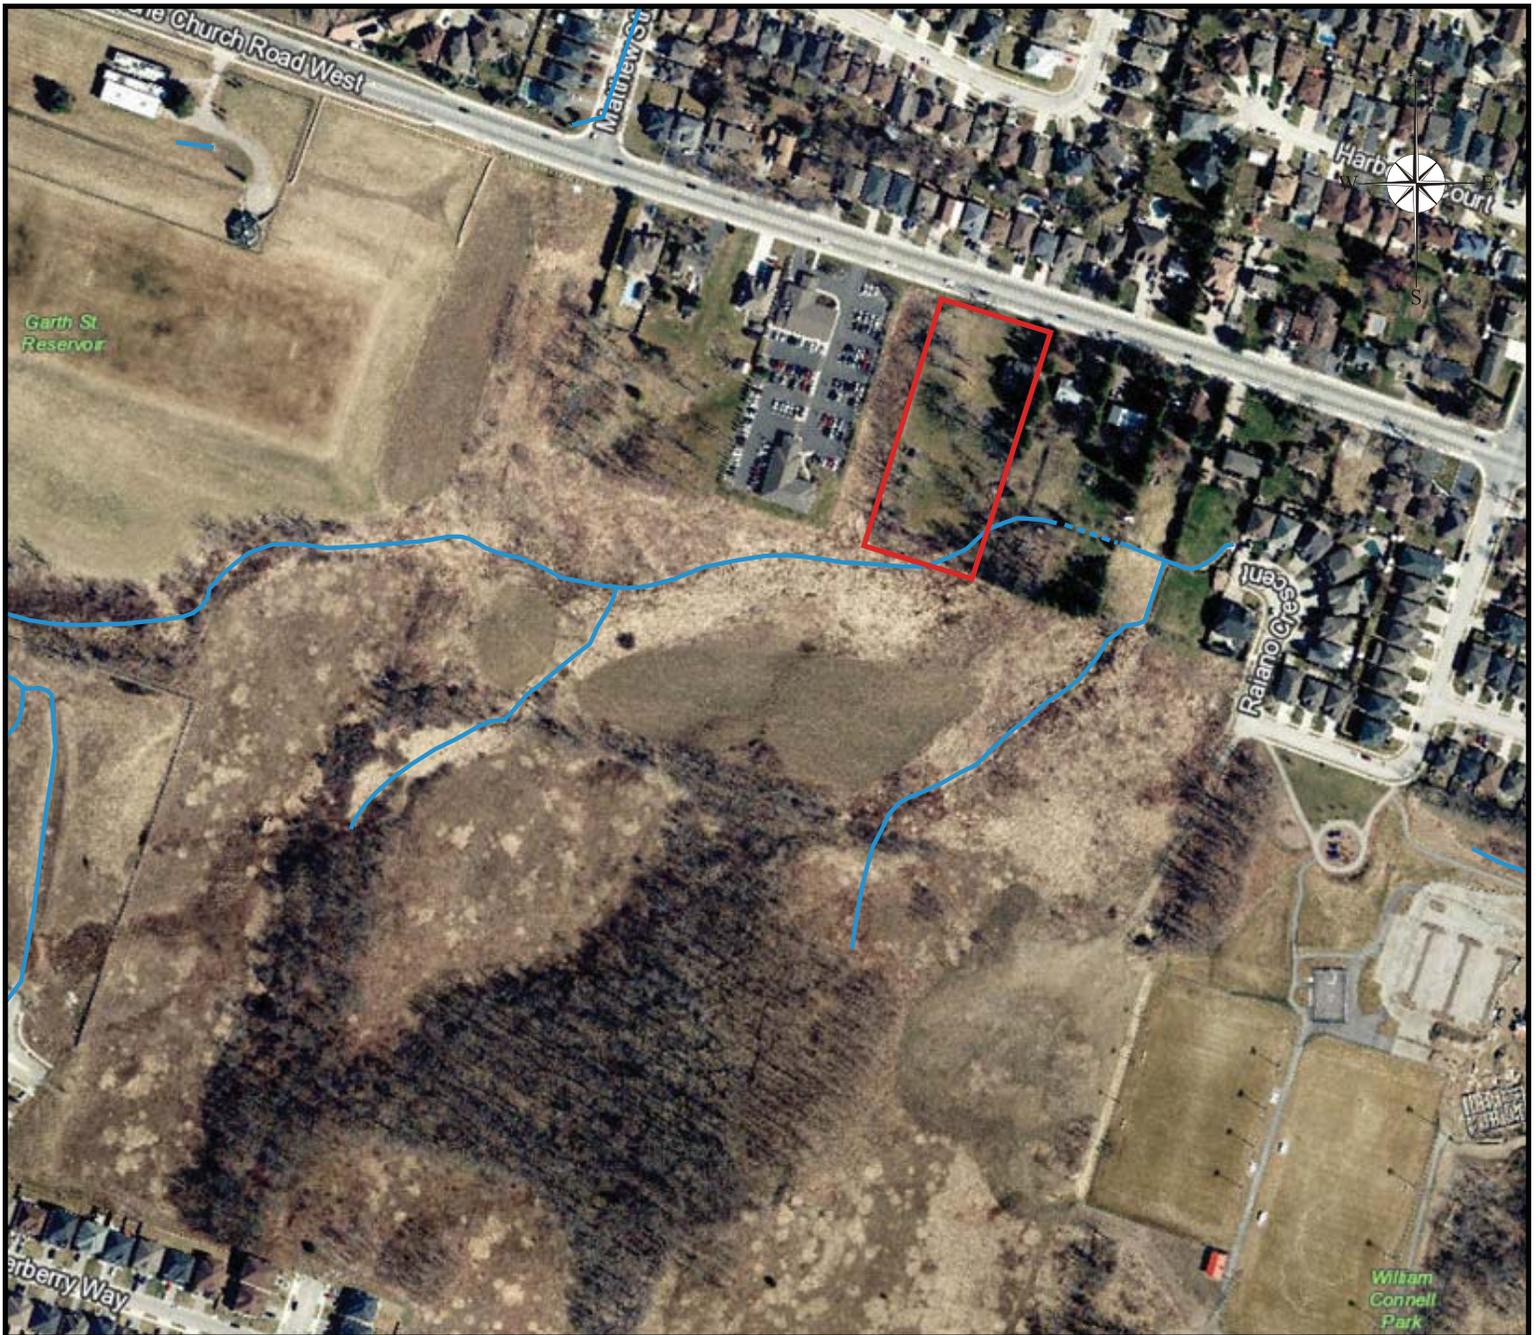
Figure 3
Refined Extent of HCA Regulated
Features on the Subject Property

As illustrated in Figure 3, a watercourse is located on the southeast corner of the Subject Property. Our assessment confirms that this feature meets the watercourse definition provided in the Conservation Authorities Act. This watercourse was determined to be an ephemeral watercourse, which conveys surface water from the property and upstream areas to the storm sewer located on the 213 Stone Church Road West property, approximately 130m downstream of the Subject Property. It is understood that water from the site is conveyed via the storm sewer approximately 5.5 to 6km to Red Hill Creek, however the actual outlet location is not known. As this feature is ephemeral and only provides flow to a storm sewer, it is our assessment that no fish habitat is present on the property and the watercourse is providing limited hydrologic functions to the watershed.

The intent of this assessment is to delineate the extent of potential regulated features on and adjacent to the property, in an effort to inform future development plans for this parcel. Regulated features on and adjacent to the property are limited to a watercourse, which contributes flow to the storm sewer downstream of the property. The refined extent of HCA regulated features are illustrated in Figure 3.

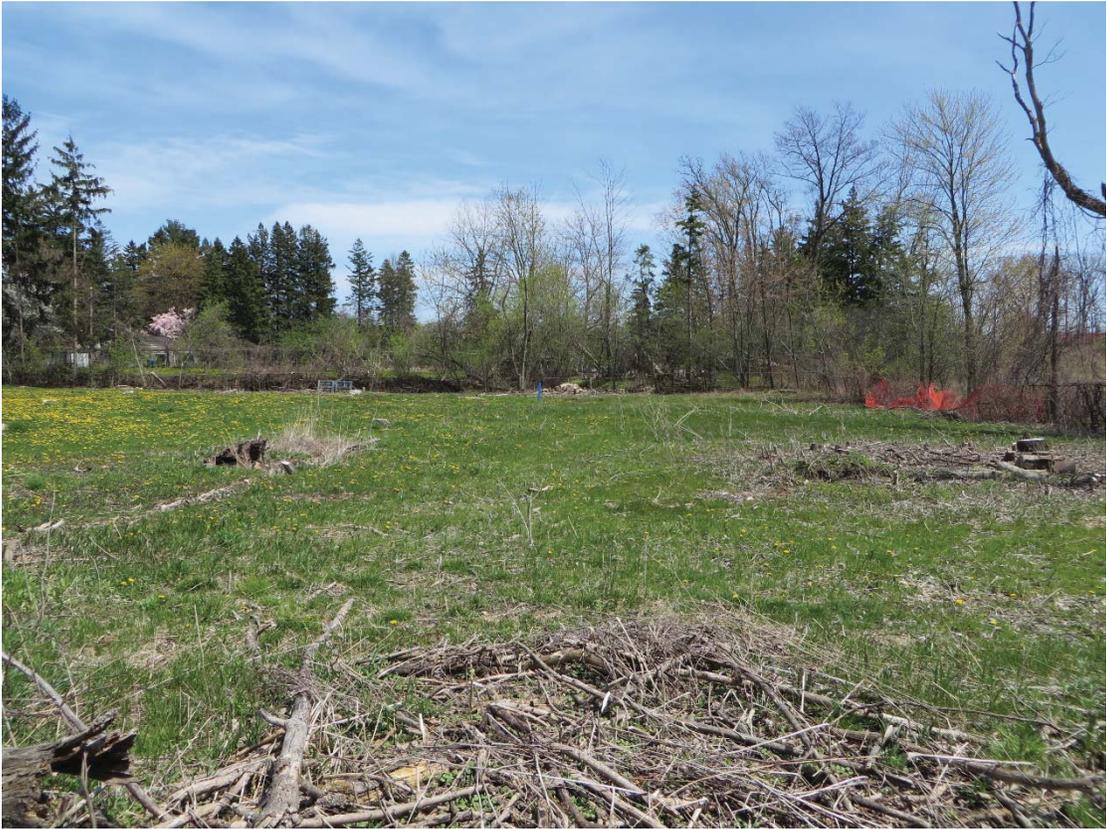
Photo 1. Example of vegetation conditions in the mowed lawn on the southern portion of the Subject Property. Photo from west property line facing east.

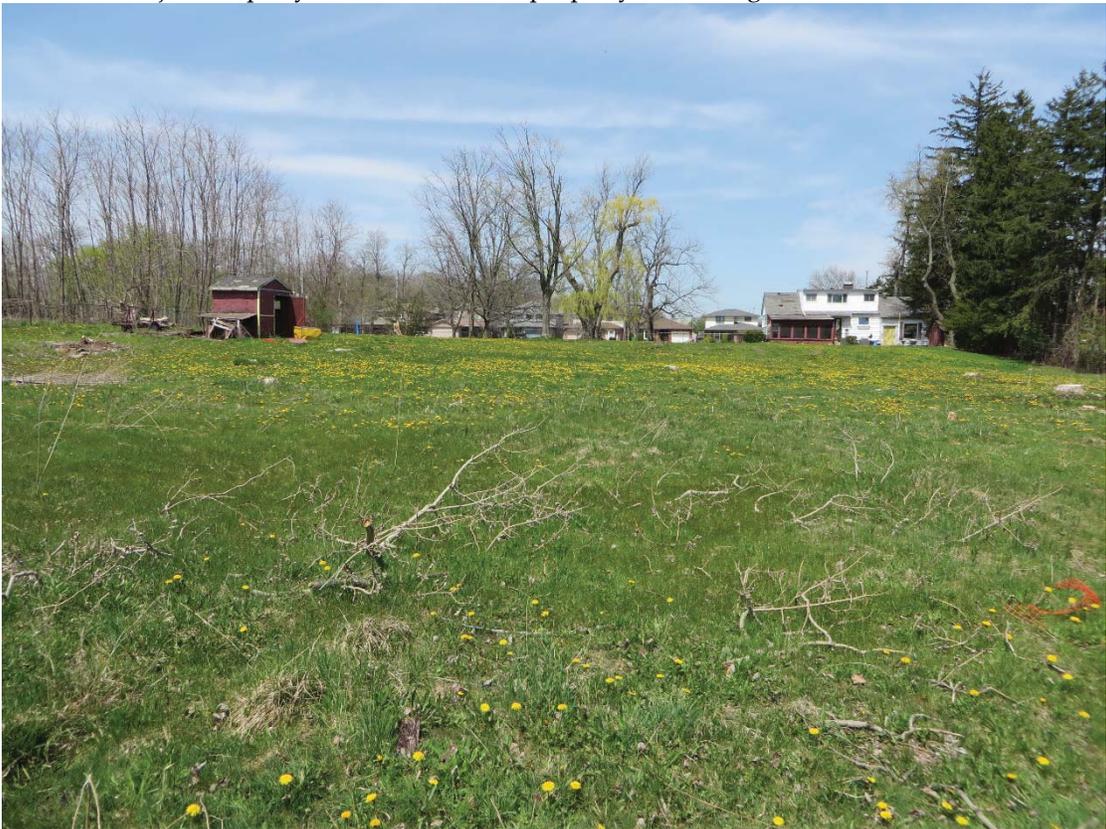
Photo 2. Example of vegetation conditions in the mowed lawn on the southern portion of the Subject Property. Photo from south end of property facing north.

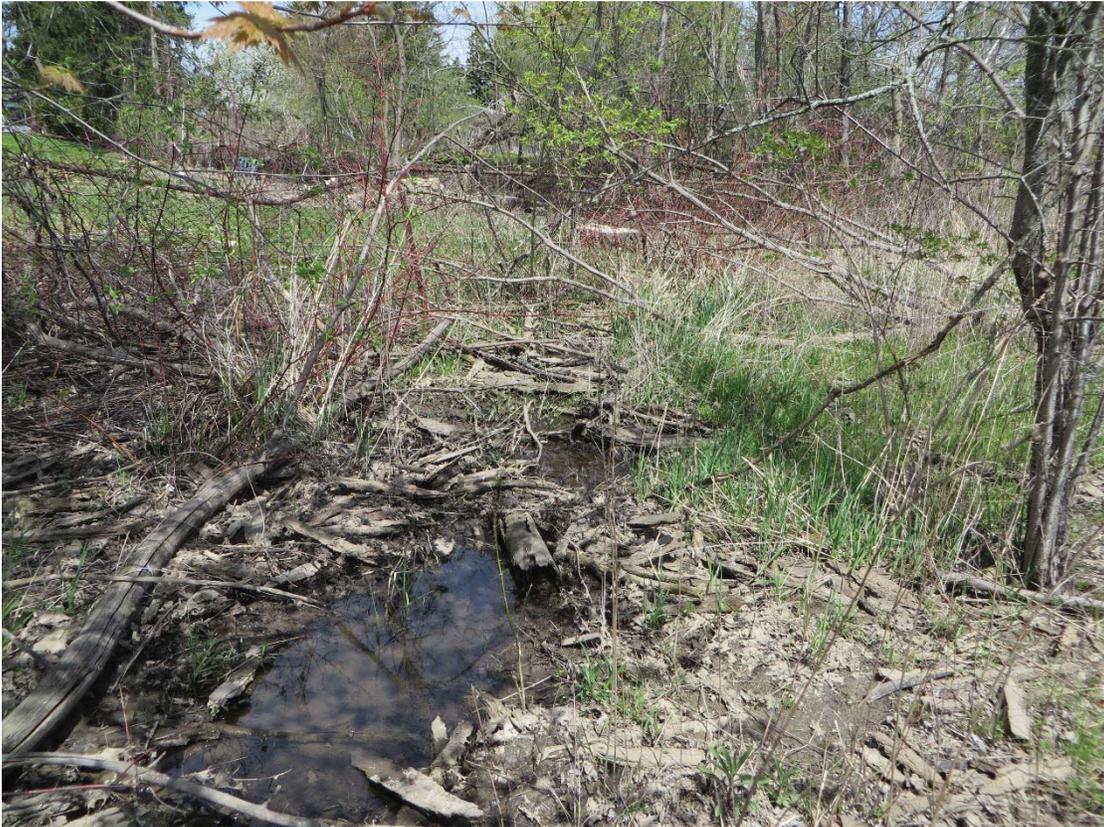
Photo 3. Example of vegetation conditions adjacent to the watercourse on the southern limit of the property. Photo from south property line facing northeast.

The watercourse channel on the property measures approximately 1 meter in width and is generally well defined (see Photos 3 and 4 in Appendix B). Channel substrates consist primarily of silty clay, with little instream vegetation present on the property. Riparian vegetation on much of the property consists primarily of grasses and sedges, which are periodically mowed. Riparian vegetation south of mowed lawn on the property consisted of species described in the MAM2-2 community above, and also included Silver Maple and Eastern Cottonwood,

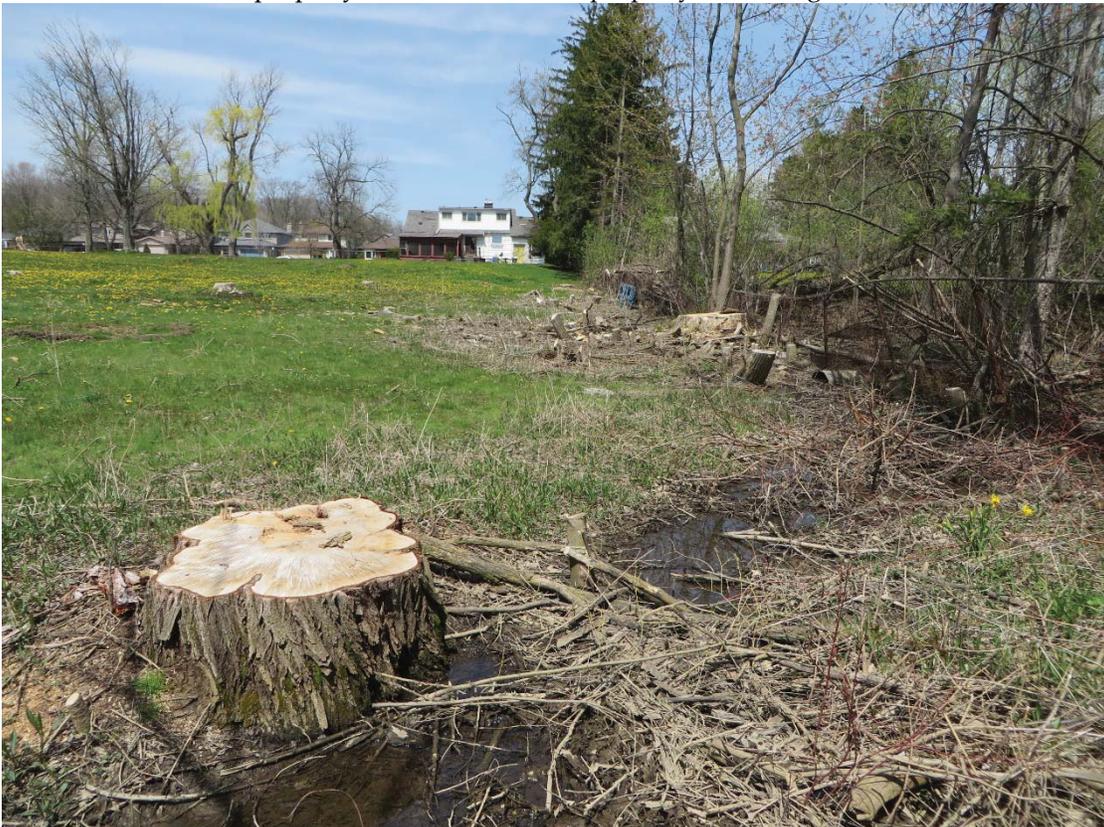
Photo 4. Example of vegetation conditions adjacent to the watercourse on property. Photo from the southern portion of the property facing north.

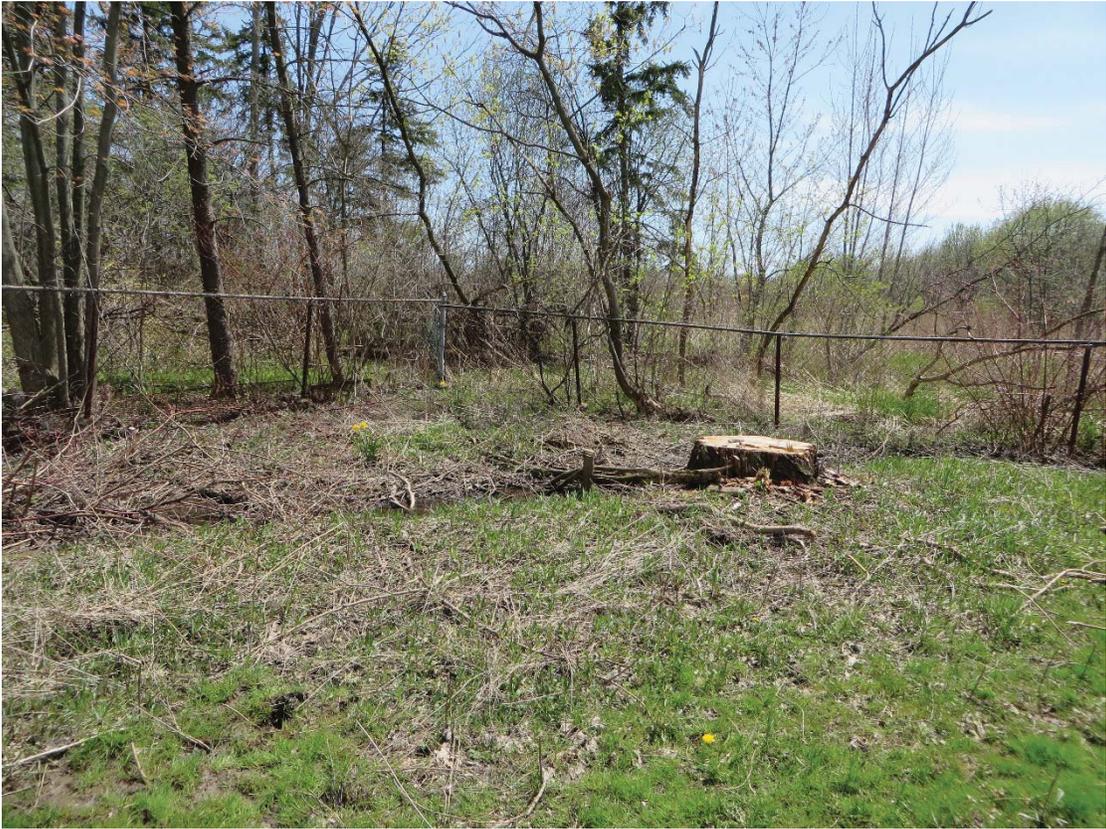
Photo 5. Example of vegetation conditions adjacent to the watercourse on property.
Photo from the southern portion of the property facing southeast.

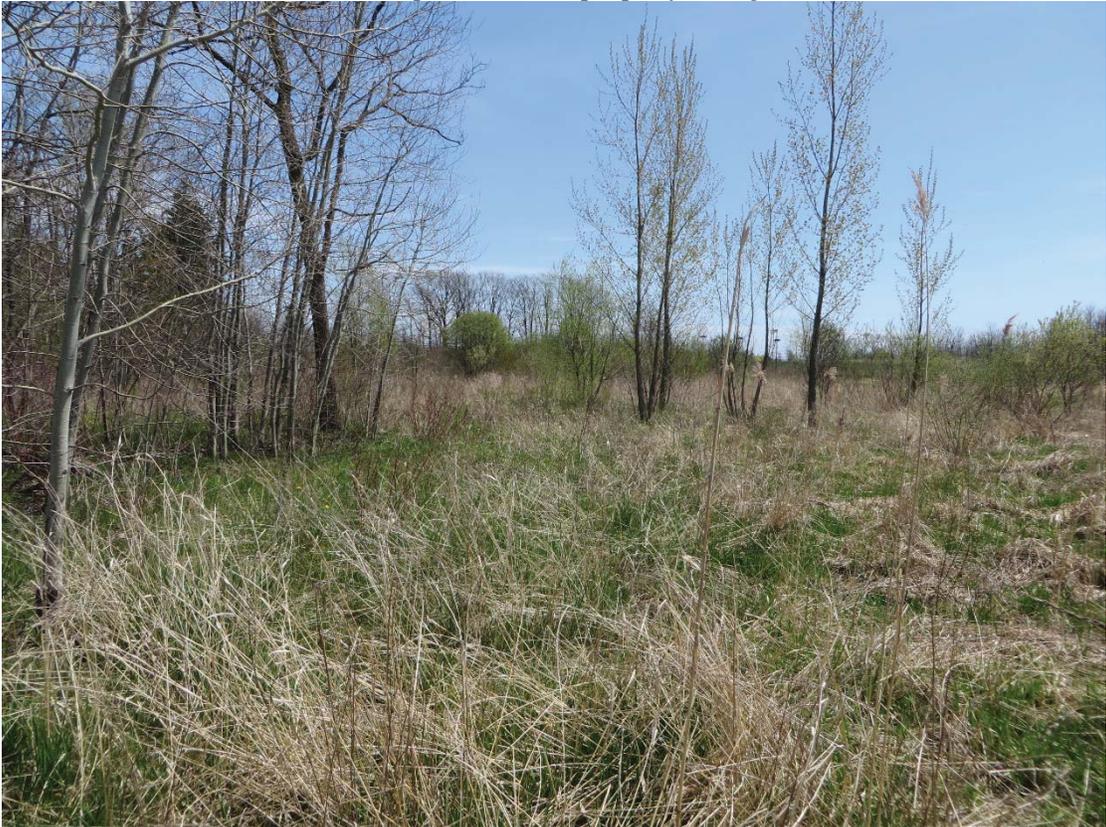
Photo 6. Example of vegetation conditions in the MAM2-2 community south of the property.
Photo from south property line facing east.

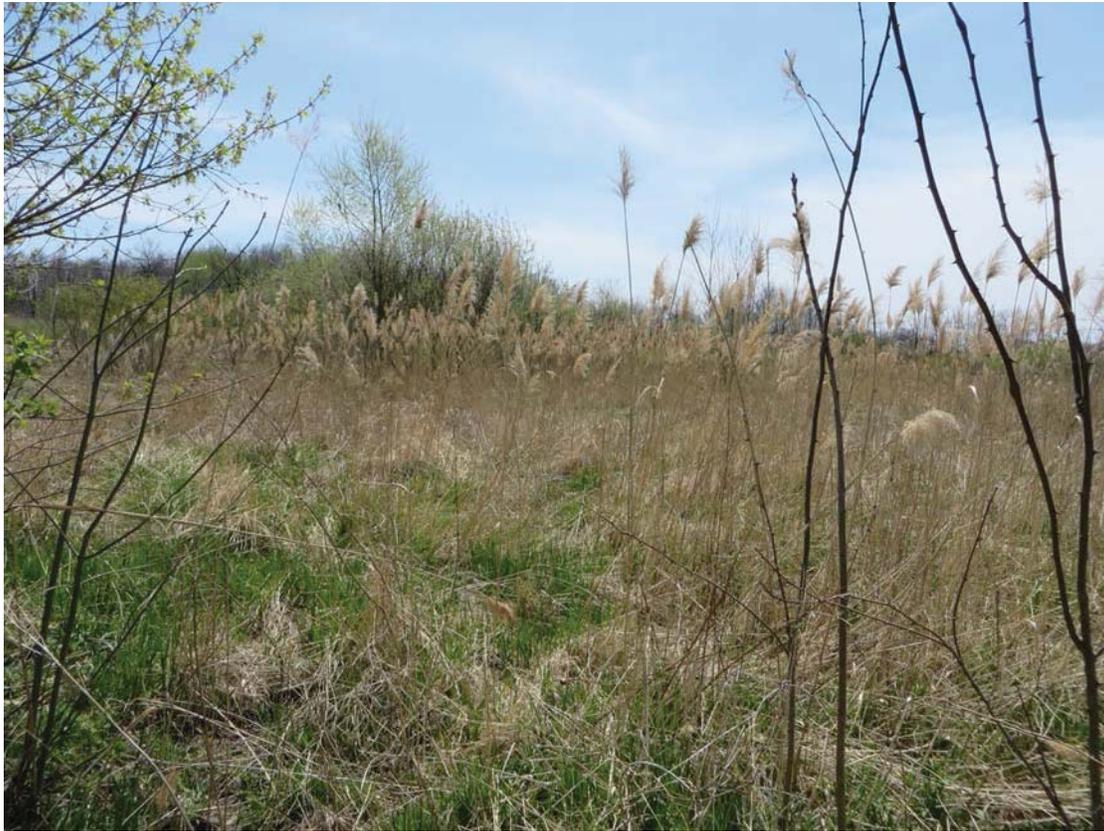
Photo 7. Example of vegetation conditions in the MAM2-2 community south of the property.
Photo from southwest corner of the property facing southeast.

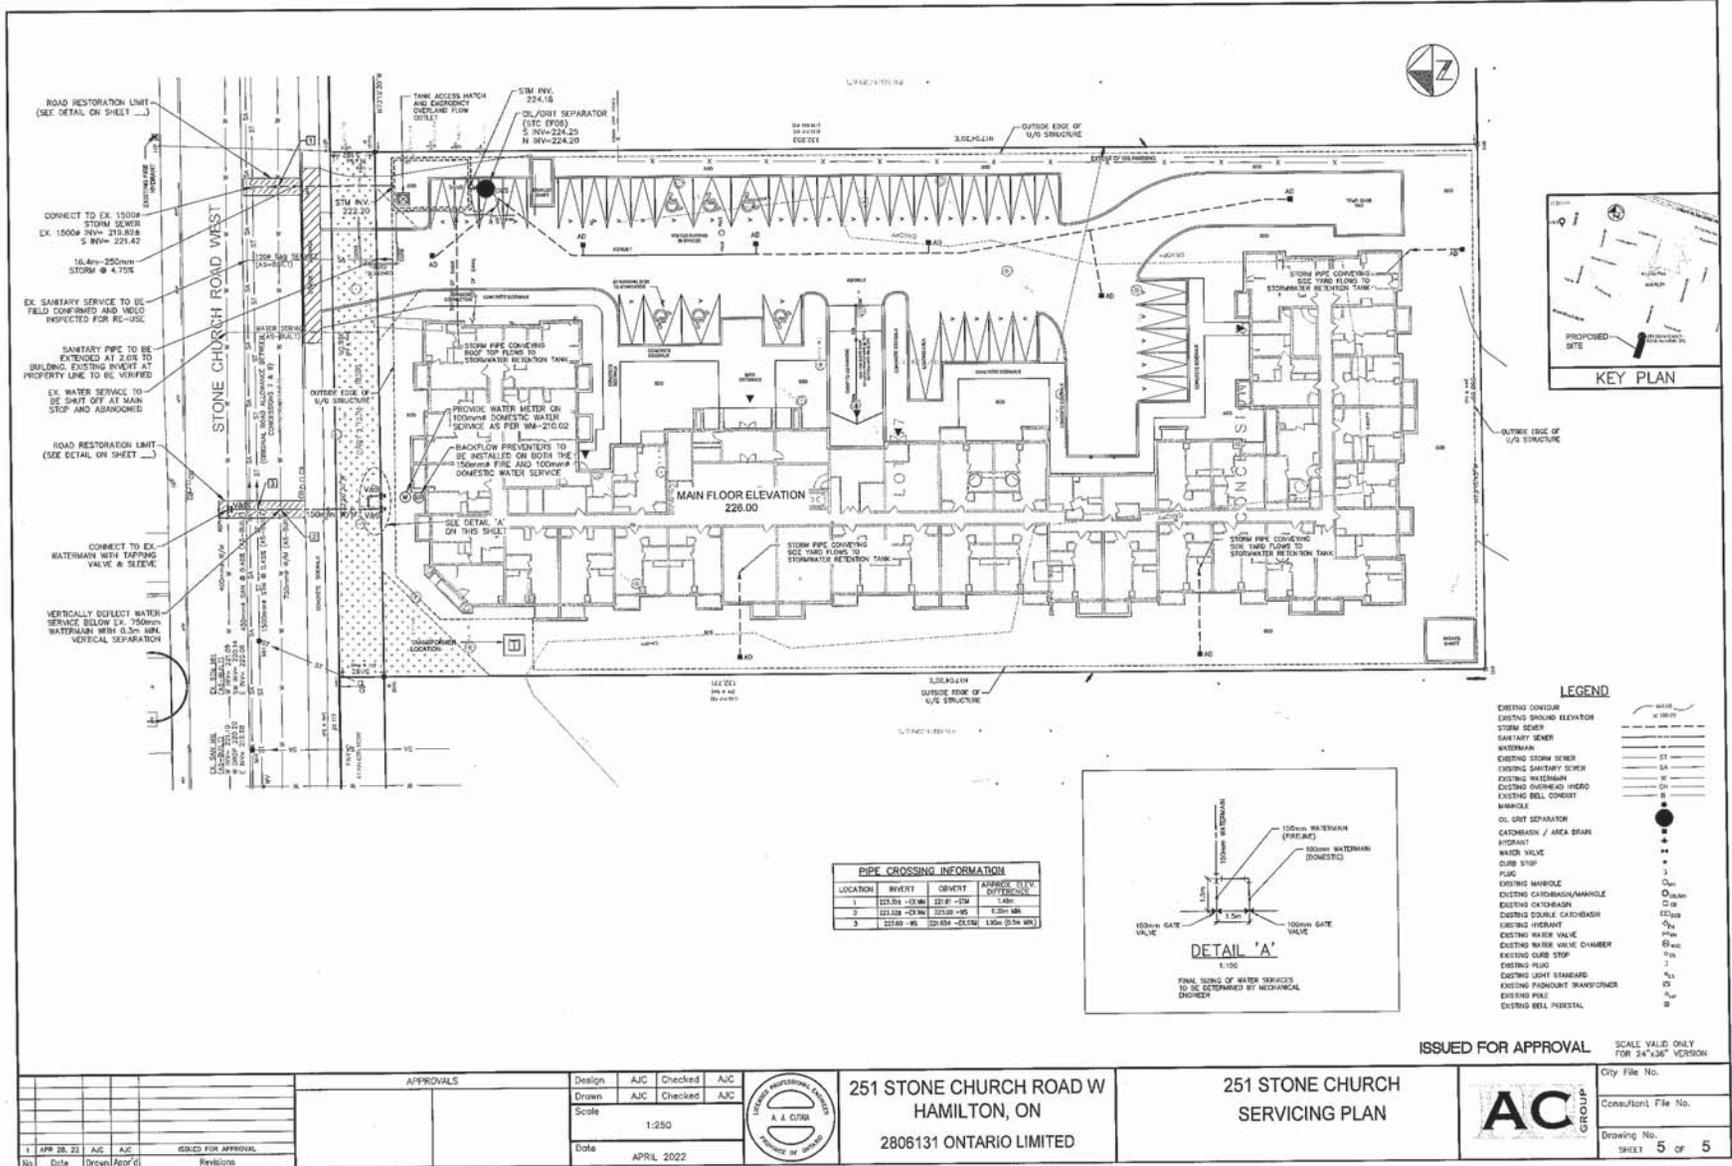
251 STONE CHURCH
SERVICING PLAN

CONNECT TO EX. 1500mm STORM SEWER EX. 1500mm INVERT 219.828 S INVERT 221.42

16.4m-350mm STORM @ 4.75%

EX. SANITARY SERVICE TO BE FIELD CONFIRMED AND MOVED PROTECTED FOR RE-USE

SANITARY PIPE TO BE EXTENDED AT 2.0% TO BUILDING EXISTING RUCKET AT PROPERTY LINE TO BE VERIFIED

EX. WATER SERVICE TO BE SHUT OFF AT MAIN STOP AND ABANDONED

CONNECT TO EX. WATERMAIN WITH TAPPING VALVE & SLEEVE

VERTICALLY DEFLECT WATER SERVICE BELOW 1.4 150mm WATERMAIN WITH 0.3m MIN. VERTICAL SEPARATION
