# HERITAGE IMPACT ASSESSMENT

TRINITY CHURCH, 10 TRINITY CHURCH ROAD  
CITY OF HAMILTON

24 APRIL 2022\_UPDATED 04 OCT 2022

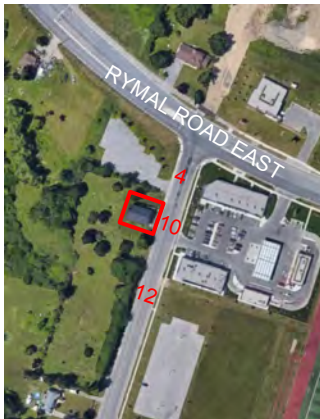
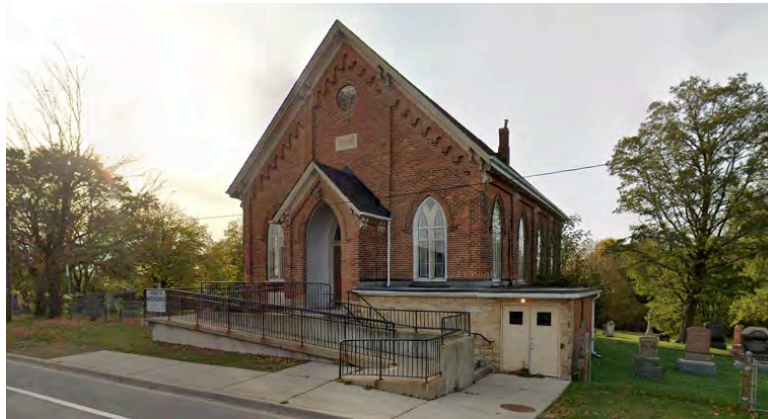
TRINITY CHURCH, 10 Trinity Church Road

The subject building constructed of brick with a raised stone foundation. It has a rectangular form and steeply pitched gable roof and a covered entrance portico on the main elevation. The building is oriented east west, with the front entrance at the east end, oriented towards Trinity Church Road. There is modern accessibility ramp at the front entrance that is constructed of concrete with metal railings.

There is a one-storey brick addition at the southeast corner of the building that contains washrooms and stairs down to the basement level. Based on the style and materials used, the addition appears to date from the mid-20<sup>th</sup> century.

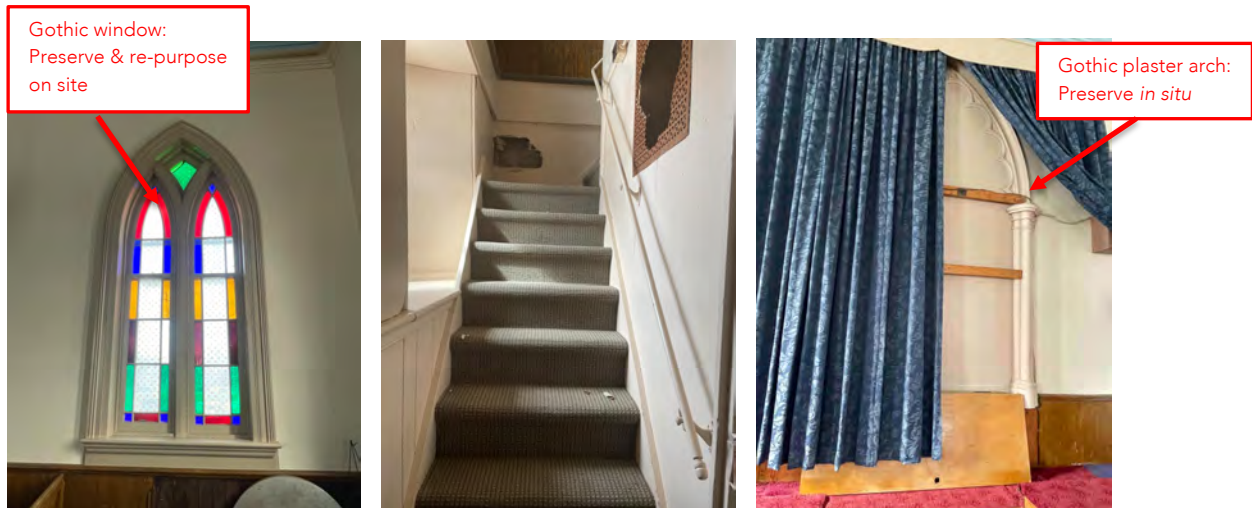
IMPACTED AREAS – **Left:** one Gothic window that is a heritage attribute will be removed where the new external elevator shaft will be attached (no. 5 above) – **Middle:** the existing stairs to the basement that will be removed are not considered to be a heritage attribute (no. 3 above) – **Right:** the Gothic frame for the altar that is a heritage attribute will be partially covered by a new partition wall (no.7 above)

NEGATIVE IMPACTS <i>Ontario Heritage Toolkit (2006)</i>	IMPACT ASSESSMENT	RECOMMENDATION
<b>Destruction</b> of any part, or part of any, significant heritage attributes or features	One Gothic window on the north elevation will be removed.	Salvage of the Gothic window and re-purposing on site as an interior feature is recommended.  Due to the limited amount of salvage, a full <i>Documentation &amp; Salvage Plan</i> is <u>not</u> required, however salvage should be undertaken by an experienced architectural salvager and further details regarding the salvage and re-purposing of this element should be provided to heritage staff.
<b>Alteration</b> that is not sympathetic, or is incompatible, with the historic fabric and appearance	Alterations will be made to the north exterior wall of the Church to accommodate a 2-storey elevator shaft that will extend above the existing 1-storey addition. Two existing window openings on the north elevation will be enlarged for the elevator doors.	A <i>Conservation Plan</i> containing detailed structural drawings and masonry specifications for changes to the north side elevation is recommended.  Masonry work should be carried out by an experienced heritage mason and should be consistent with the City of Hamilton's <i>Masonry Restoration Guidelines</i>

MITIGATION STRATEGIES <i>Ontario Heritage Toolkit (2006)</i>	MITIGATION MEASURES	RECOMMENDATION
<b>DIRECT IMPACTS</b>		
Alternative development approaches	Impacts on heritage attributes have been avoided, with the exception of one Gothic window on the north elevation that will be removed where the elevator shaft will be attached.	An alternative development approach is not necessary because the impacts are minor and negative impacts can be mitigated.
Isolating development and site alteration from significant built and natural features and vistas	n/a	-
Design guidelines that harmonized mass, setback, setting, and materials	Design measures have been successfully employed so that the proposed elevator shaft on the north side elevation will set back from the front façade, contained within the first bay of the side elevation, and not extend above the roofline so that it is not visually intrusive. Removal of the concrete ramp at the front entrance and changes to the existing front	The historic church is red brick with a limestone foundation. It has a later addition that is clad with red brick and limestone that was carefully matched to the historic church. A similar approach for the elevator addition is encouraged and it is recommended that the final material and colour choices be reviewed by heritage staff for final approval.

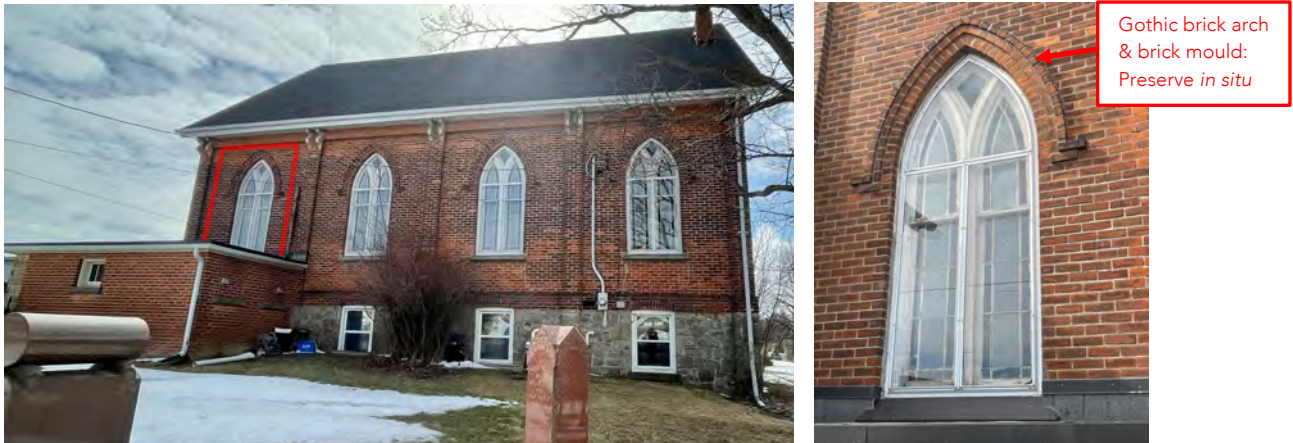
ELEVATOR ADDITION ON NORTH ELEVATION – two existing window openings will be utilized for access to the proposed elevator that will extend above the existing one-storey addition. (no. 5 above)

stairs will enhance the main elevation.	
Limiting height and density	n/a	
Allowing only compatible infill and additions	The new elevator shaft will be introduced within the existing building footprint and will utilize two existing masonry openings to provide connection on the basement and first floor. The roof of the addition will be below the eaves of the church roof.	
Reversible alterations	The changes are minimal and are considered reversible.	<p>Salvage and on-site retention of one Gothic window has been recommended to allow for possible reinstatement in the future.</p> <p>It is recommended that the Gothic brick arch and brick hood mould above this window be preserved <i>in situ</i> and the enclosure for the elevator be built around it.</p> <p>It is recommended that the Gothic plaster arch in the interior be preserved <i>in situ</i> where a new partition wall is being built to create a private dining room in the Sanctuary.</p>

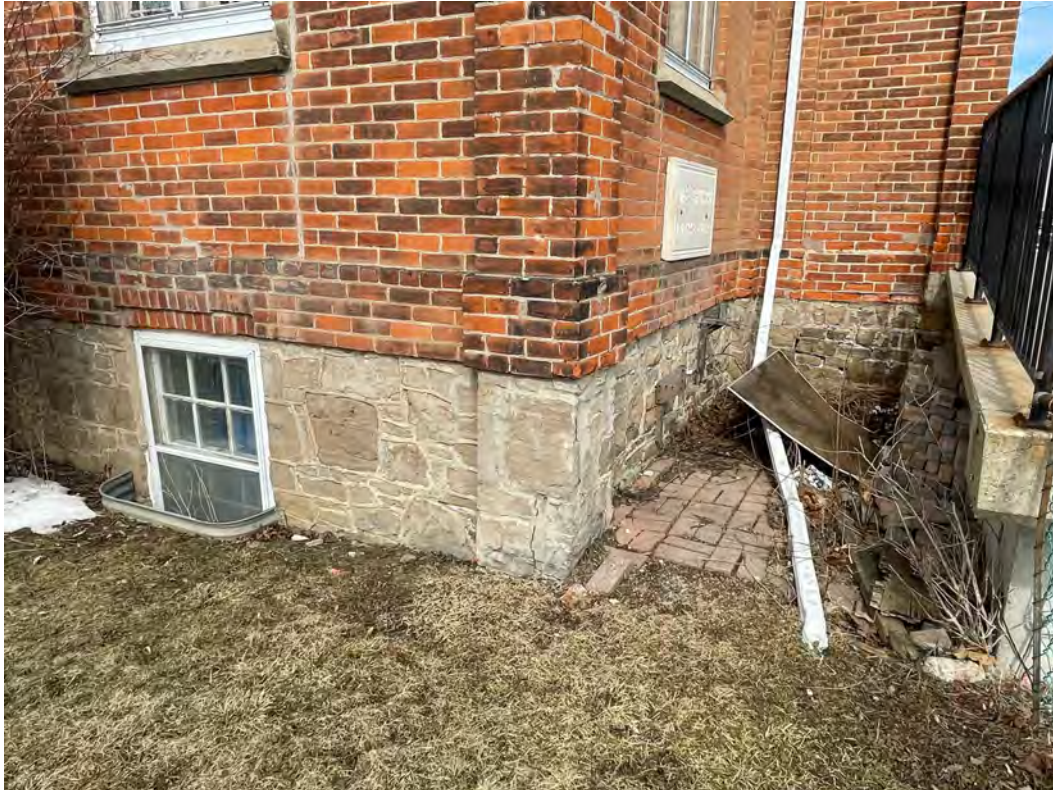
RAISED STONE FOUNDATION

- the exterior masonry walls constructed of multi-wythe brick with shallow brick buttresses, and randomly coursed raised stone foundation
- the canted cut stone window sills, the raised brick Gothic hood moulds, and the raised brick corbels on the main elevation

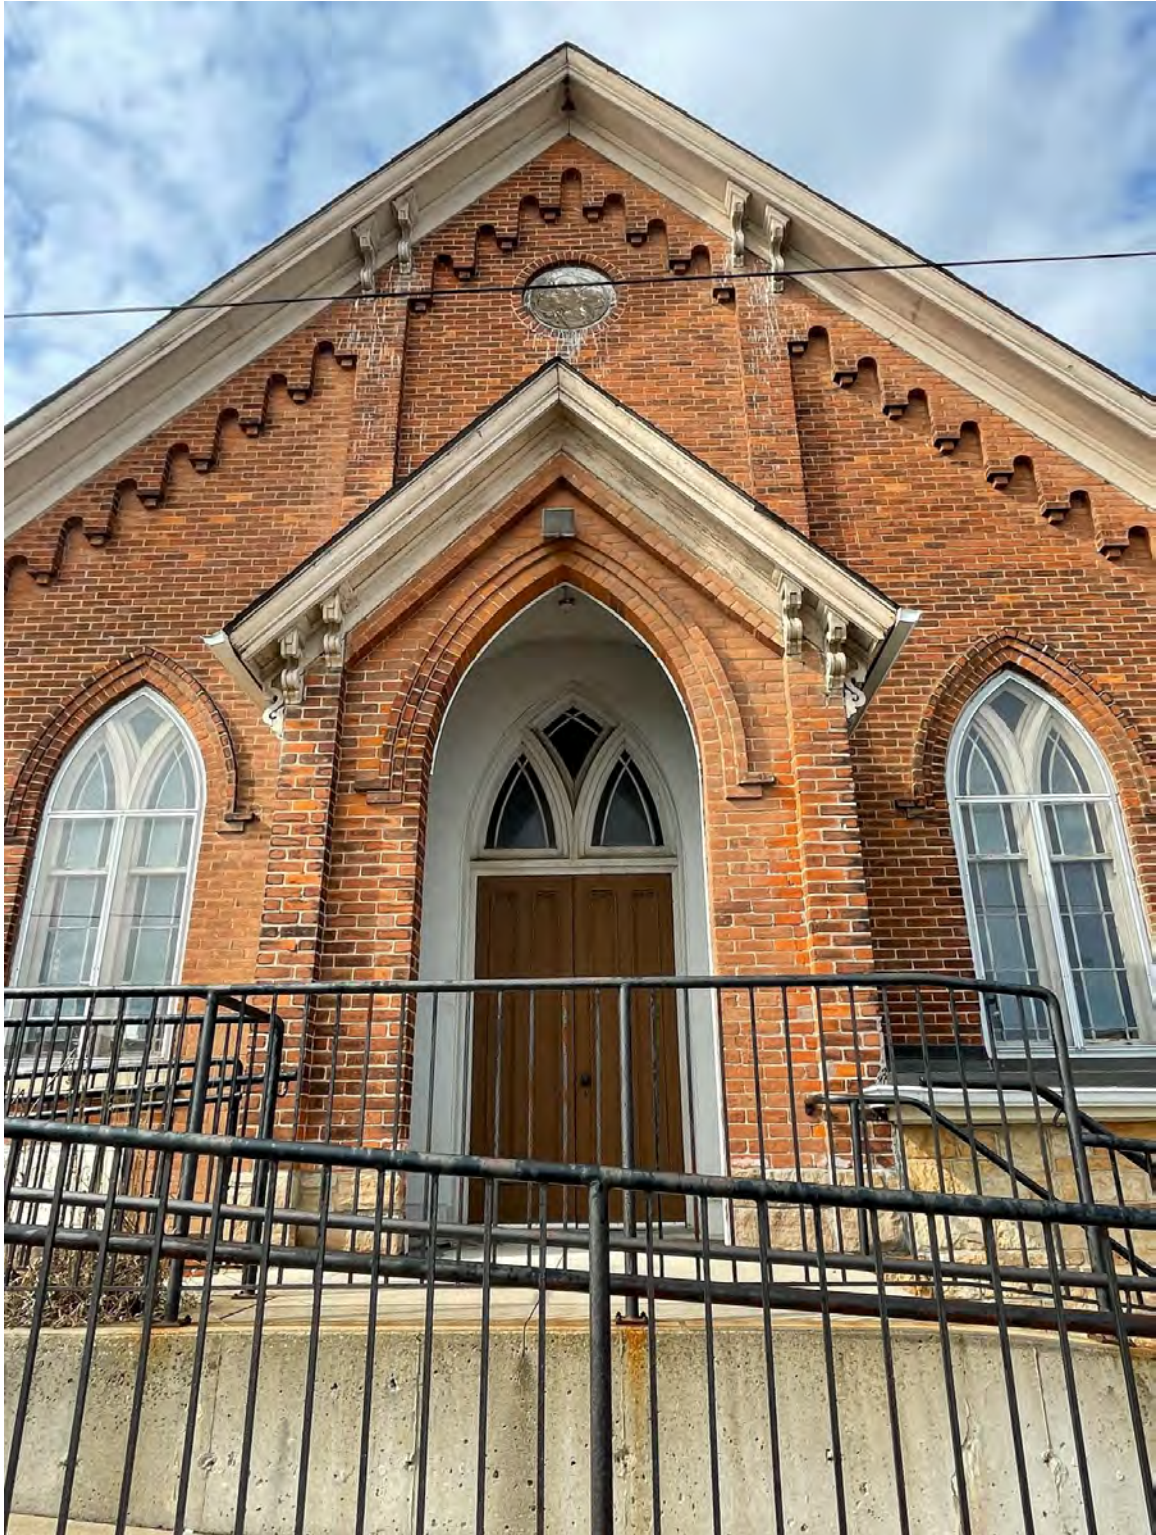
FRONT ENTRANCE AND CONCRETE ACCESSIBILITY RAMP

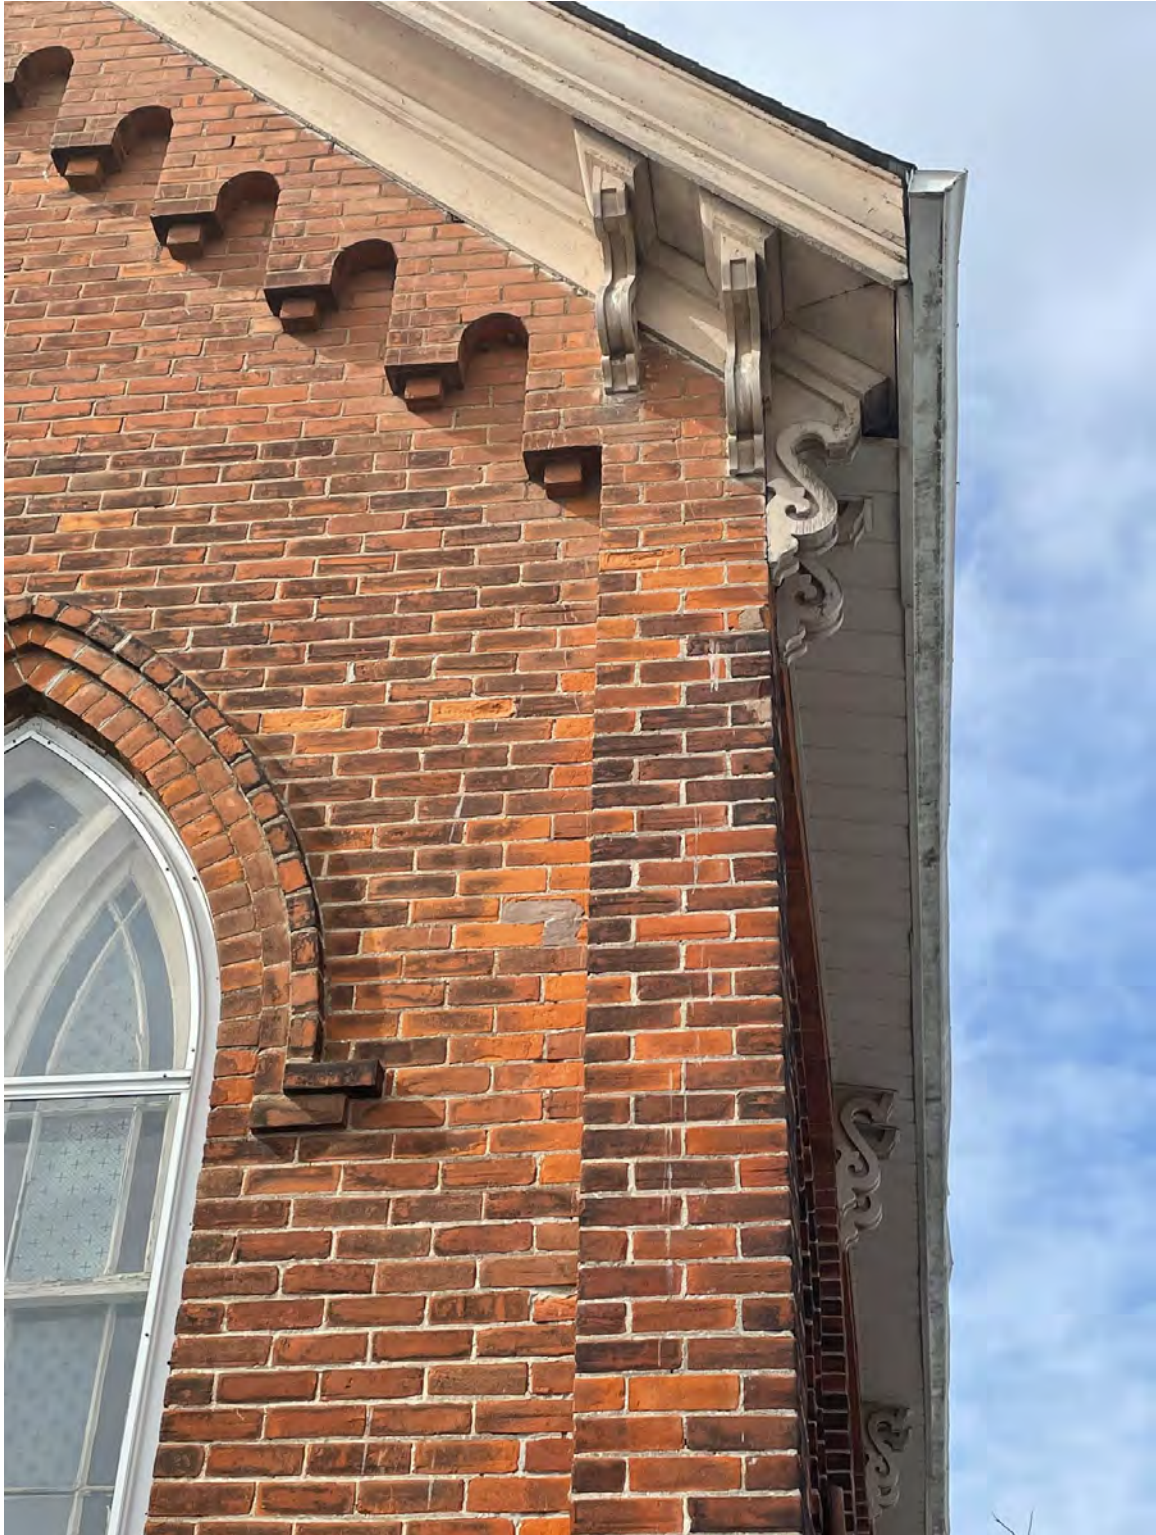
DECORATIVE WOOD BRACKETS, BRICK CORBELLING, SHALLOW BRICK BUTTRESS, & RAISED BRICK HOOD MOULD

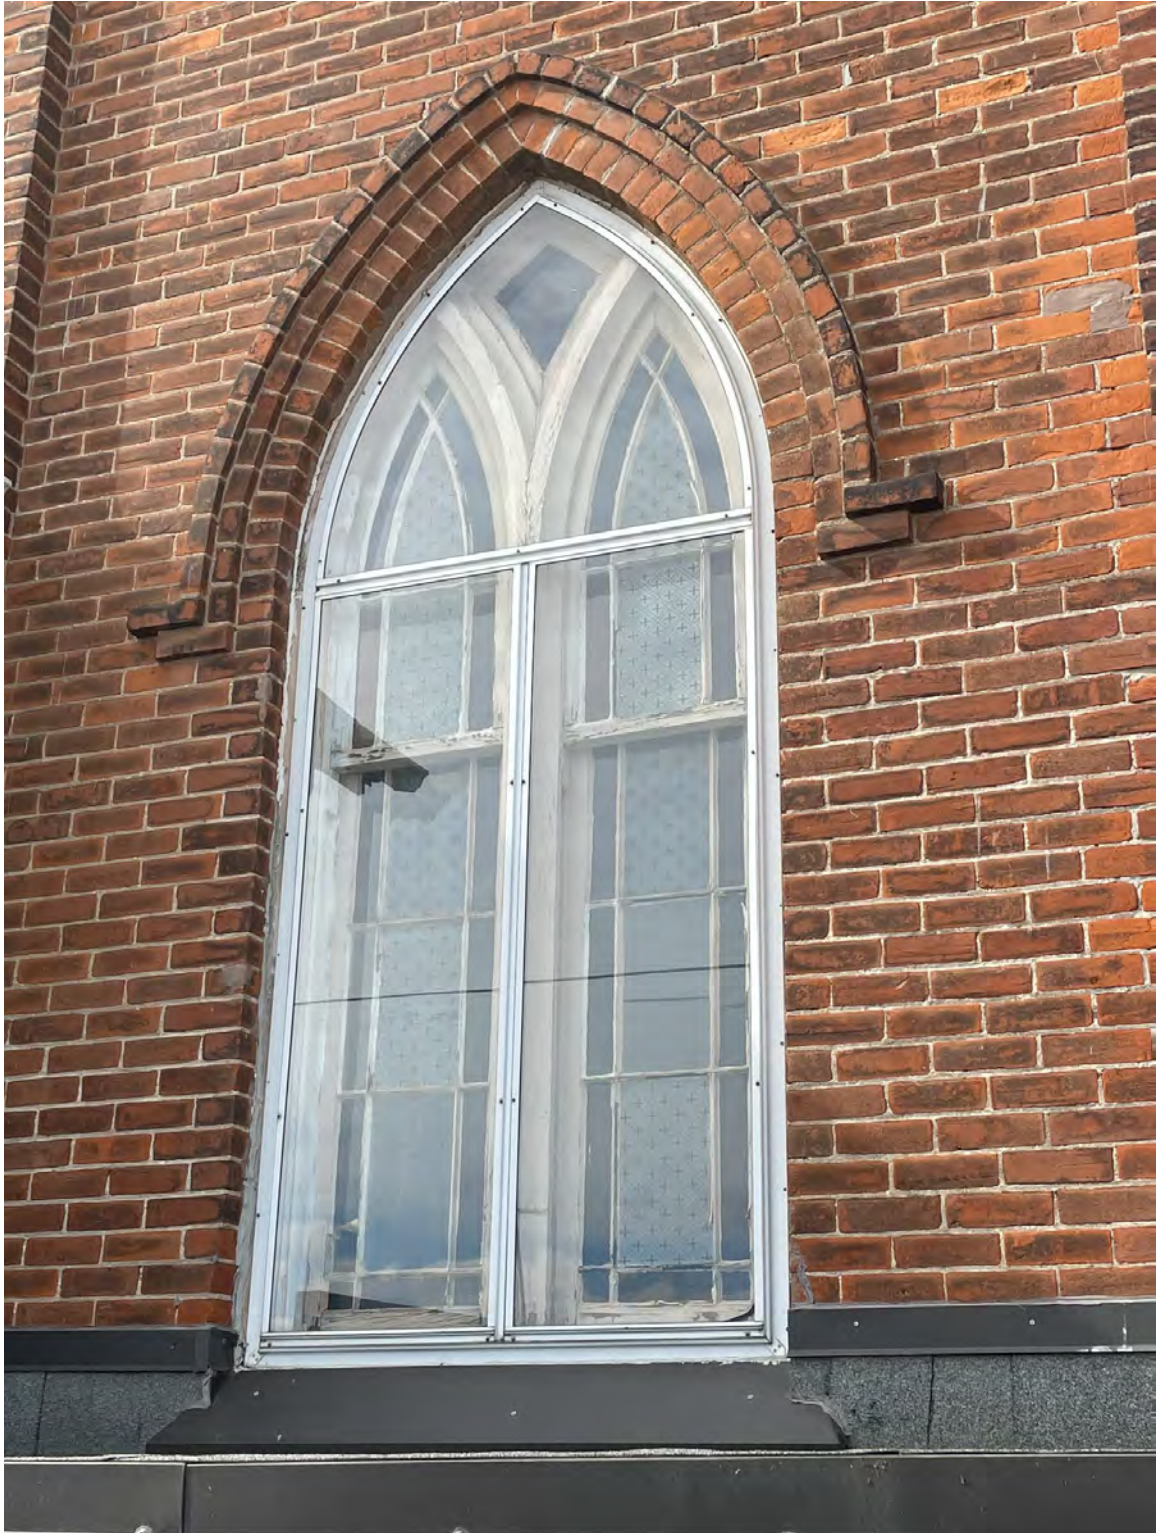
POINTED GOTHIC WINDOWS WITH A RAISED BRICK HOOD MOULD – PAIRED LANCET WINDOW WITH COLOURED GLASS – METAL FRAMED EXTERIOR STORMS INSTALLED

- the pointed arched Gothic windows on the front and side elevations with coloured glass
- the pointed arched Gothic window on the rear elevation with a stained-glass memorial window dedicated to 'Pilot Officer Robert Cecil Fletcher, d. Mar 31, 1945, Hamburg, Germany'

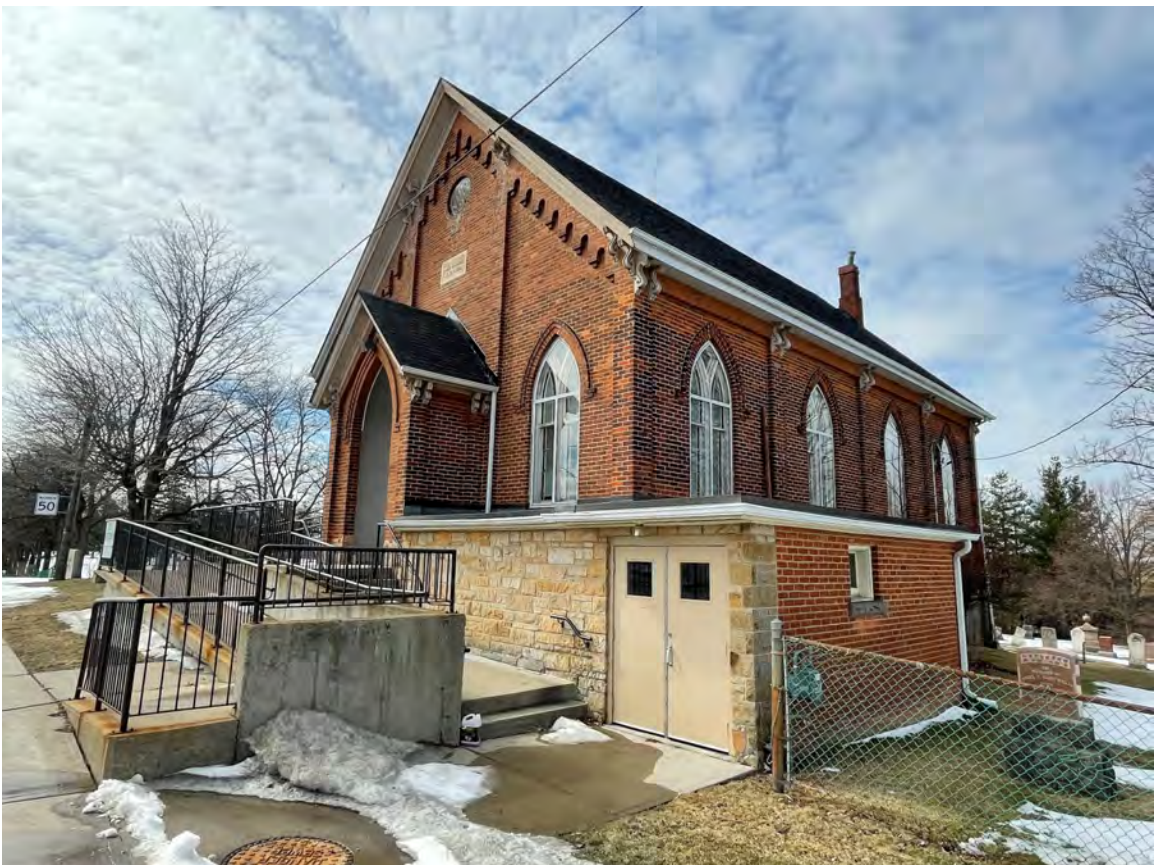
20<sup>TH</sup> CENTURY ADDITION – 1-STOREY WITH BRICK AND STONE CLADDING TO MATCH THE CHURCH

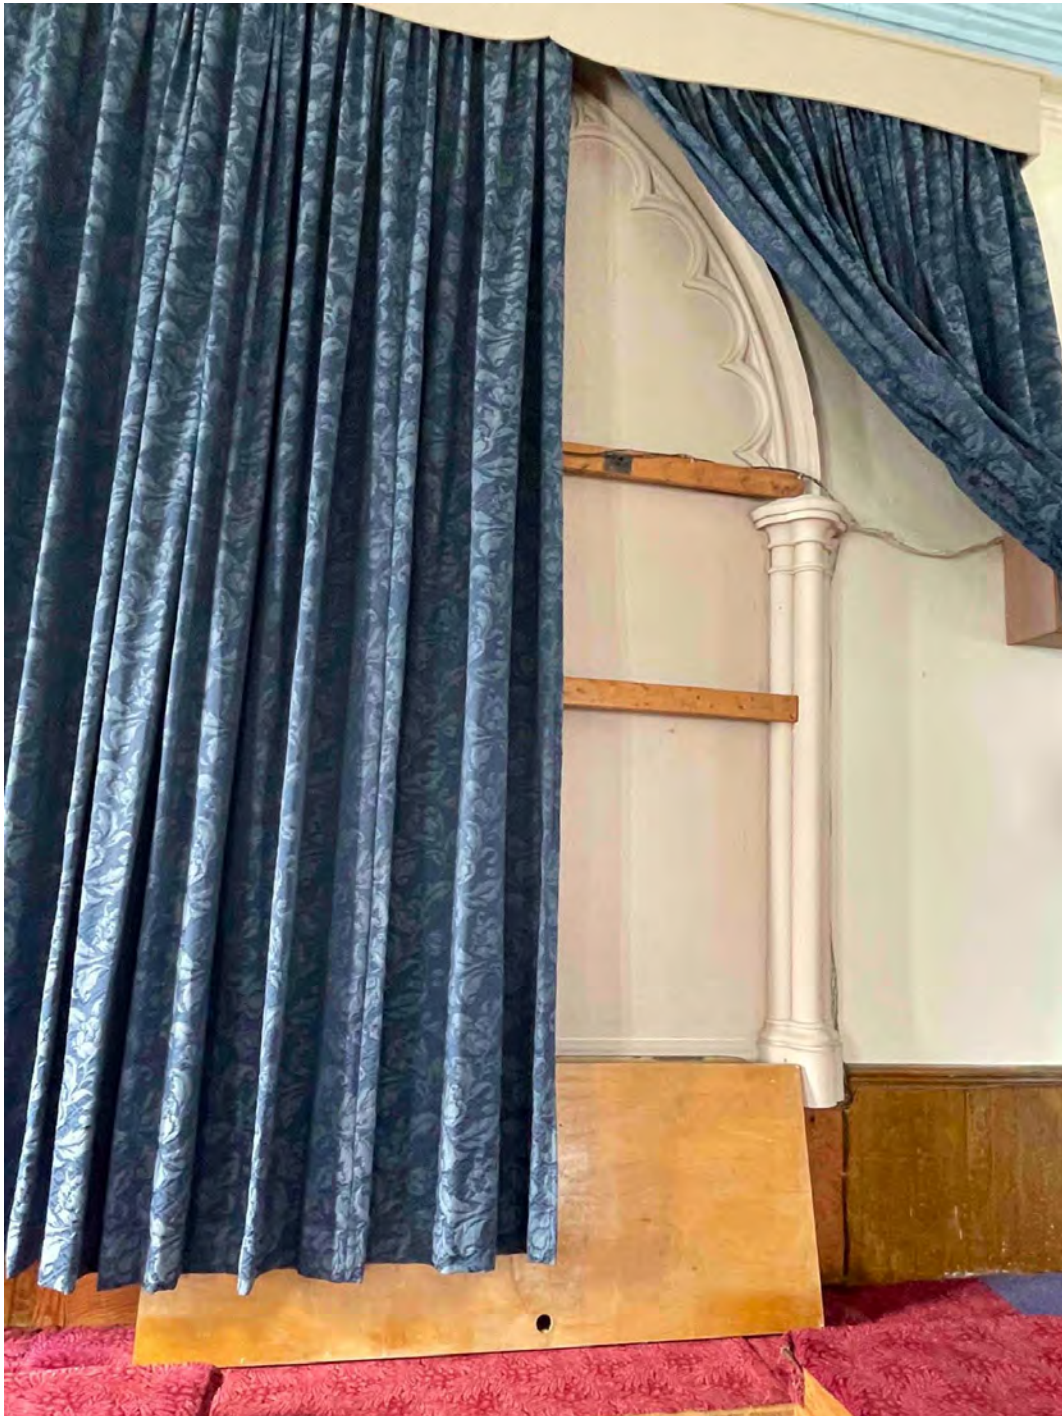
GOTHIC FRAME WHERE THE METHODIST ALTAR WOULD HAVE BEEN LOCATED

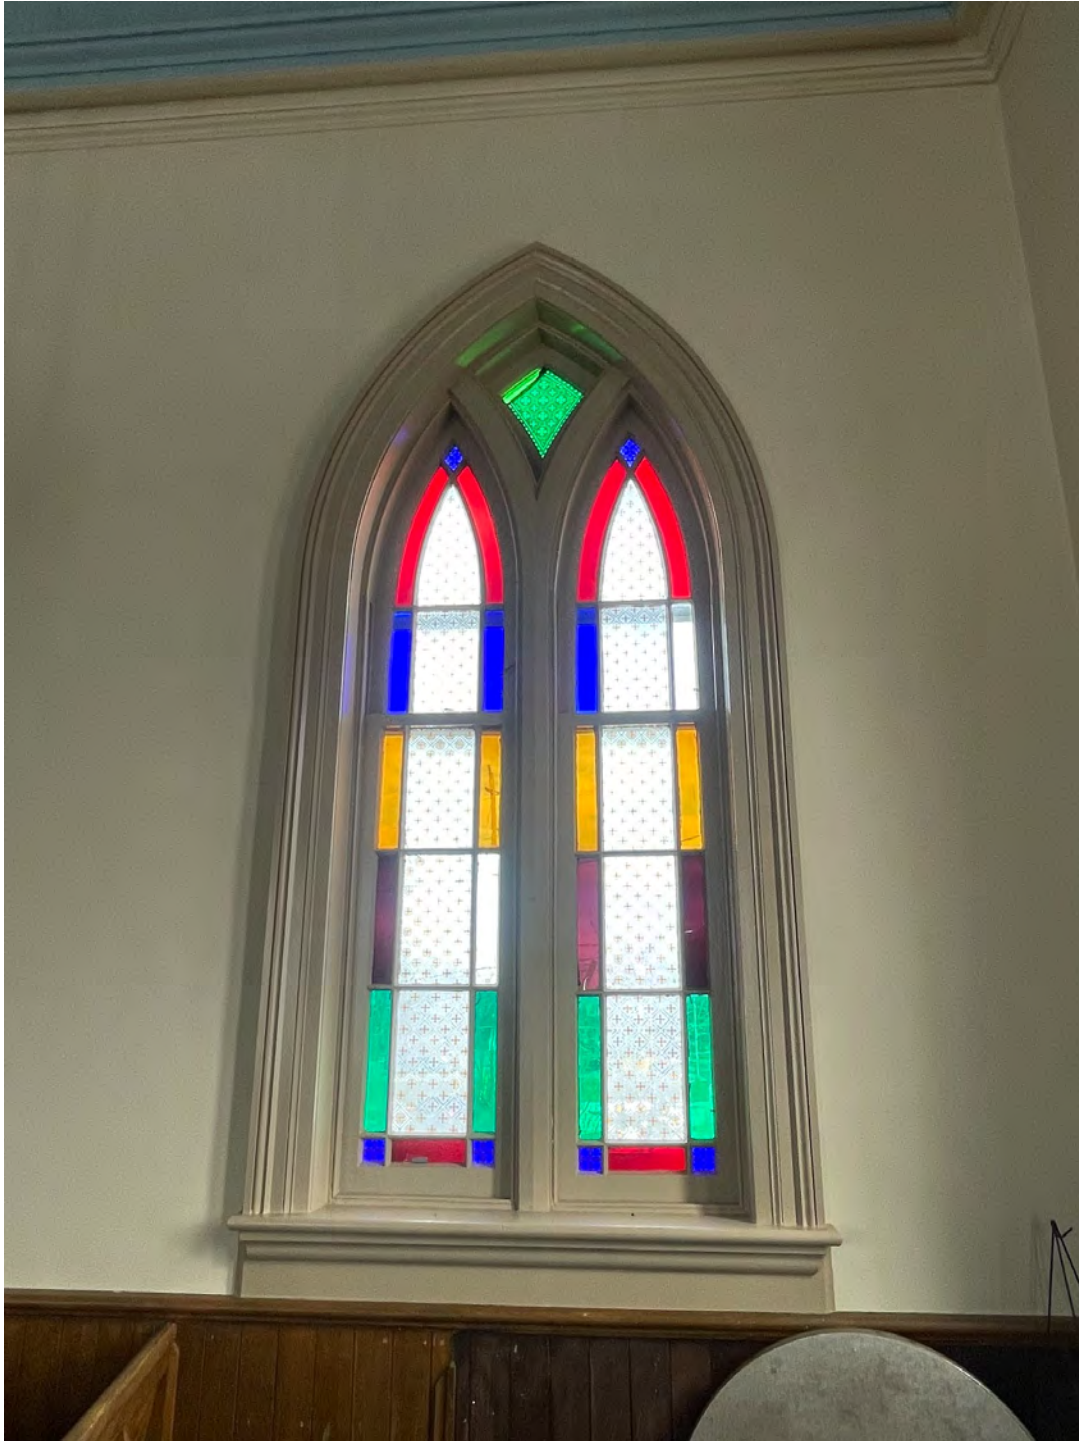
SANCTUARY WINDOW WITH COLOURED & ETCHED GLASS

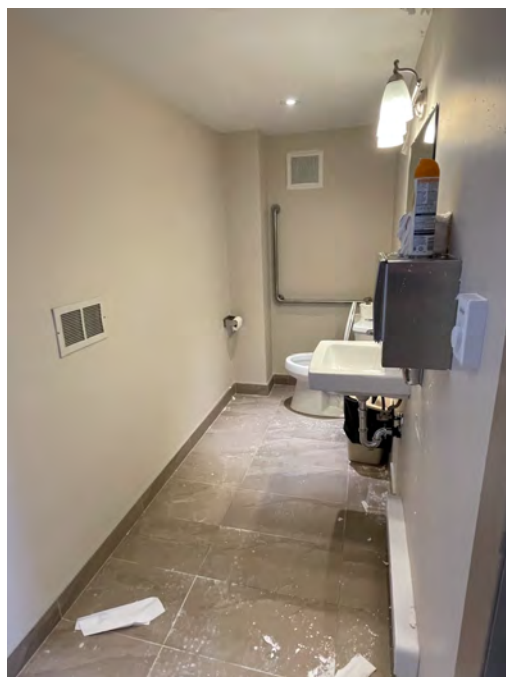
ADDITION – 2 WASHROOMS INCLUDING ONE ACCESSIBLE WASHROOM

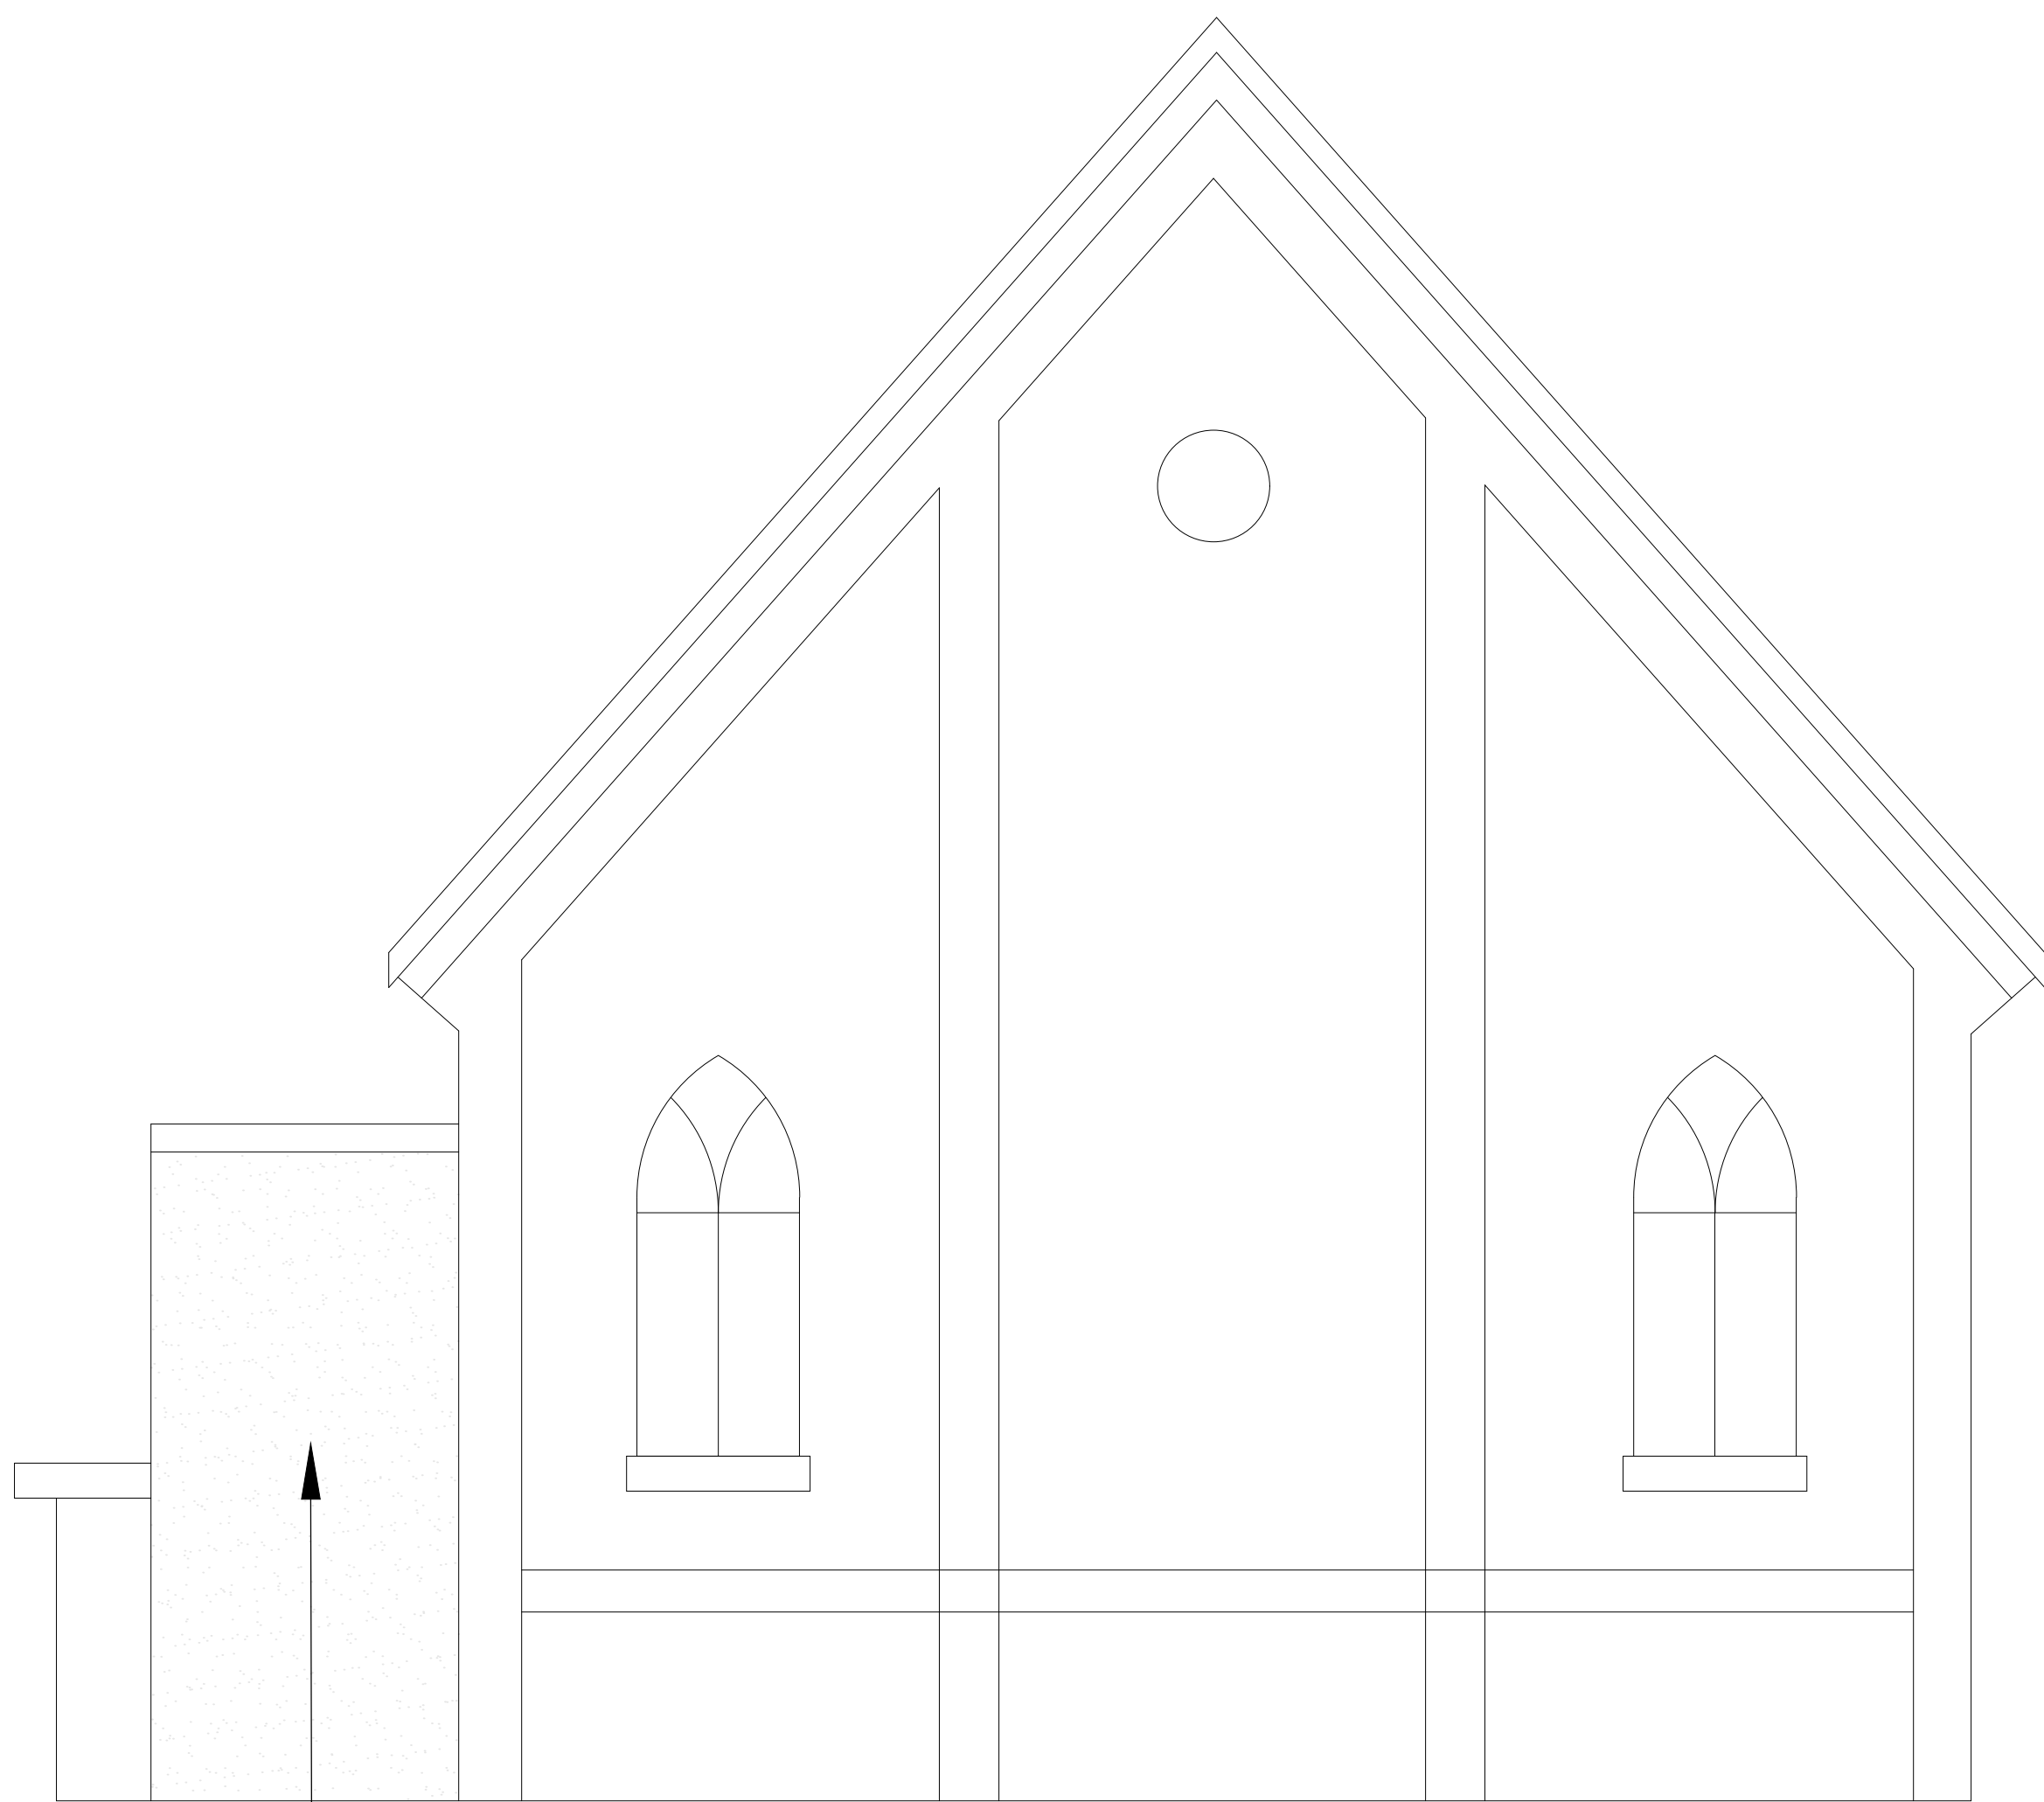
A04.00

WEST ELEVATION

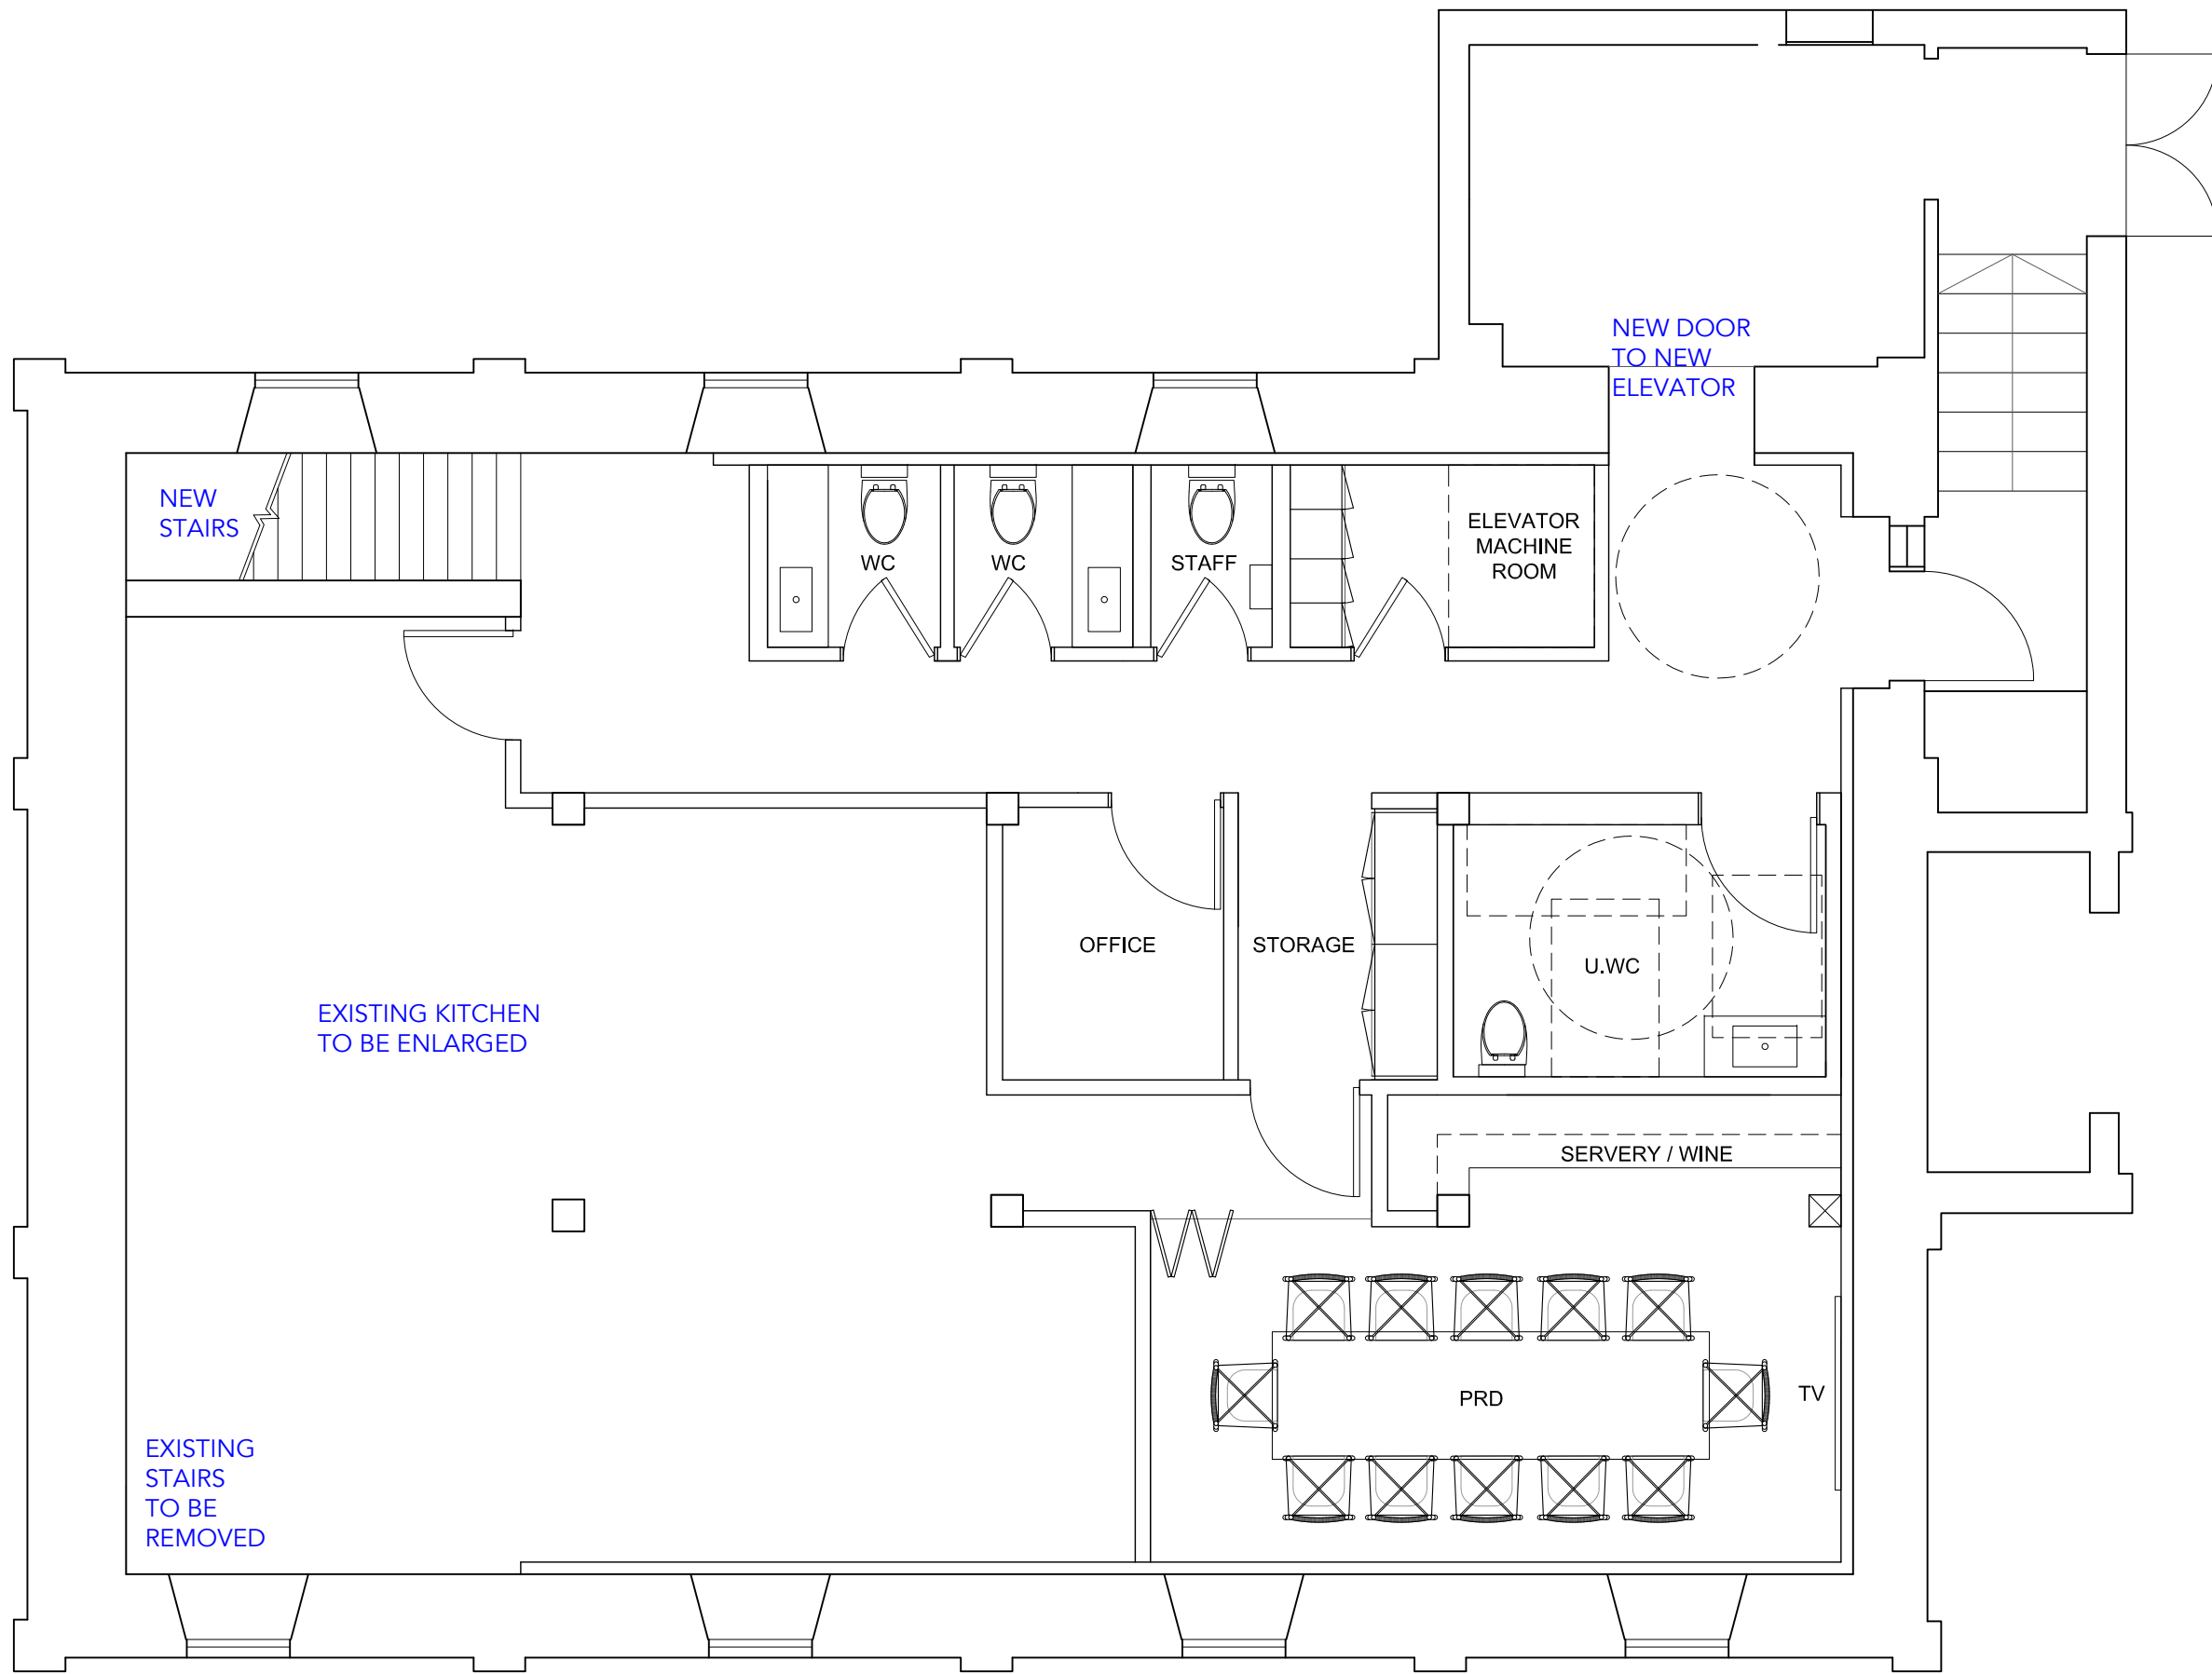
EXISTING  
RAMP  
TO BE  
DEMOLISHED

EXISTING  
STAIRS TO BASEMENT  
TO BE REMOVED
